Access Compliance Report Public Rights-of-Way (Curb Ramps)

Intersection ID: 13143 Main Street: OSMOND_ST Cross Street: BETHEL_RD Location: SE

ADA ID: E5A3BA4BC0BF Ramp Type: BlendTrans1 Initial Pass/Fail: Fail Overall Compliance: No Severity Score: 18.75

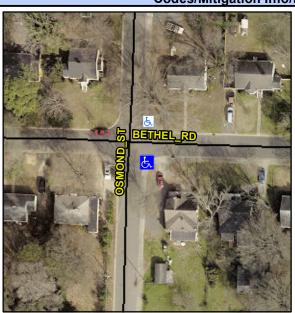
Not Found, R304.5.1, R304.5.3

Compliance Description Data Compliance Description Data Ramp Length (in) Yes BlendTrans Slope (%) N/A 59.0 2.5 No No Ramp Width (in) 34.5 BlendTrans XSlope (%) 4.4 N/A N/A Flare Type LT N/A Flare Type RT N/A N/A Flare Slope LT (%) N/A N/A Flare Slope RT (%) N/A N/A Flare Traversable LT? N/A N/A Flare Traversable RT? N/A N/A Landing Length (in) N/A N/A **DWS Provided?** N/A N/A Landing Width (in) N/A N/A **DWS Contrast?** N/A N/A N/A N/A Landing Slope (%) DWS Length (in) N/A N/A Landing X Slope (%) N/A N/A DWS Full Width? N/A N/A Landing Curb? (Y/N) N/A N/A DWS Offset (in) N/A N/A N/A Shared Landing? N/A **Gutter Ponding?** N/A N/A Gutter Slope (%) N/A N/A Gutter Lip Ht (in) N/A N/A Gutter X Slope (%) N/A N/A Painted X Walk1? No N/A Painted X Walk2? No X Walk 1 Direction To N X Walk 2 Direction To W N/A X Walk 1 Width (in) X Walk 2 Width (in) N/A X Walk 1 Slope (%) 4.7 X Walk 2 Slope (%) 2.6 X Walk 1 X Slope (%) 0.6 X Walk 2 X Slope (%) 4.0 N/A N/A Ramp inside XWalk2? N/A N/A Ramp inside XWalk1? Road Slope (%) 2.4 Clear Space? N/A Road X Slope (%) 3.0 N/A Clear Space to XWalk (in) N/A N/A N/A N/A Any Obstructions? Storm Grate/Utility Hazard? N/A **Obstruction Type** Storm Grate/Utility Type N/A N/A Yes Surface Condition? (G/P) Good

Remove & Replace Curb Ramp With Two New Directional Ramps or Equivalent.
