Access Compliance Report Public Rights-of-Way (Curb Ramps)

Intersection ID: 11414Main Street:LIBETH_STCross Street:SHAMROCK_DRLocation:SEADA ID: E5A639941DB4Ramp Type:ParaInitial Pass/Fail:FailOverall Compliance:NoSeverity Score:10

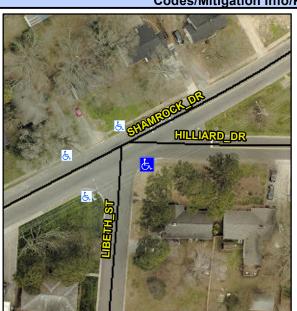
RT RP < 5%, NO RT SW

N/A
N/A
N/A
N/A
R304.5.1, R304.5.3

Remove & Replace Entire Ramp.
