# Access Compliance Report

## Public Rights-of-Way

### (Curb Ramps)

| Intersection ID: 8534 | Main Street: ATANDO_AV | Cross Street: LASALLE_ST | Location: NE |

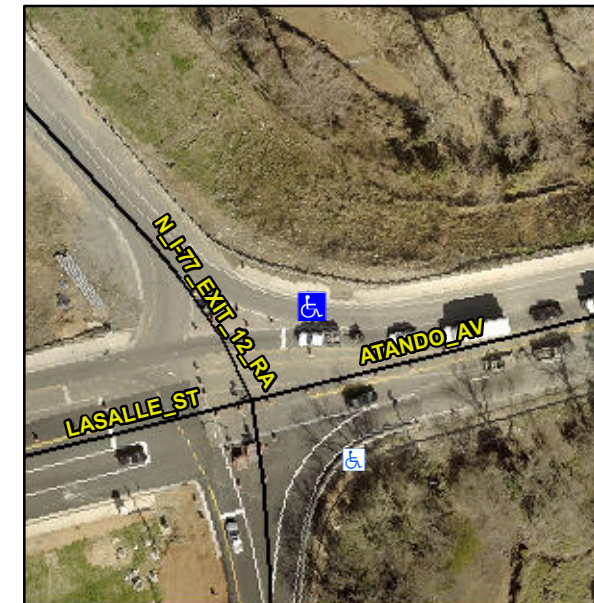
**Not Found, R304.2.1, R304.5.3, R304.2.3**

| Compliance | Description | Data | Compliance | Description | Data |
|---|---|---|---|---|---|
| No | Landing Length (in) | 47.0 | Yes | DWS Provided? | Yes |
| No | Landing X Slope (%) | 2.8 | Yes | DWS Full Width? | Yes |

**Remove & Replace Curb Ramp With Two New Directional Ramps or Equivalent.**
