# Access Compliance Report

## Public Rights-of-Way

### (Curb Ramps)

Intersection ID: 5885	Main Street: ADONIS_CT	Cross Street: HELLEBORE_RD	Location: SW
ADA ID: E5D0EDA3C4B6	Ramp Type: Perp	Initial Pass/Fail: Fail	Overall Compliance: No
Severity Score: 1.25			
Codes/Mitigation Info/Possible Solution		Field Measurements/Component Compliance

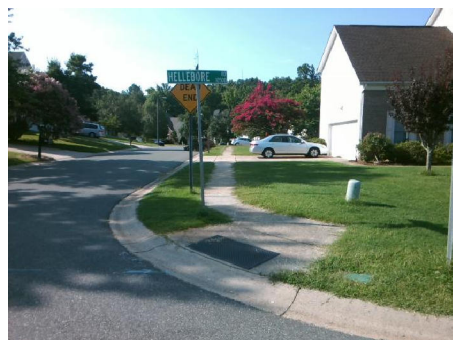
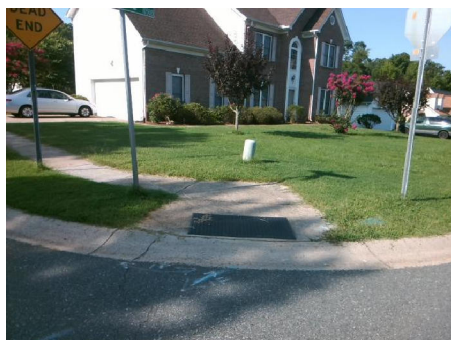
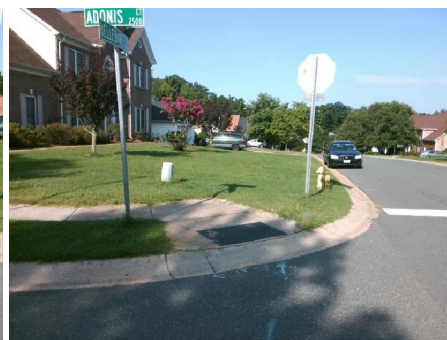
**Not Found, R304.5.3**

Compliance	Description	Data	Compliance	Description	Data
N/A	Ramp Length (in)	47.0	Yes	Ramp Slope (%)	6.9
Yes	Ramp Width (in)	80.0	No	Ramp XSlope (%)	2.3
N/A	Flare Type LT	N/A	N/A	Flare Type RT	N/A
N/A	Flare Slope LT (%)	N/A	N/A	Flare Slope RT (%)	N/A
N/A	Flare Traversable LT?	N/A	N/A	Flare Traversable RT?	N/A
N/A	Landing Length (in)	N/A	N/A	DWS Provided?	N/A
N/A	Landing Width (in)	N/A	N/A	DWS Contrast?	N/A
N/A	Landing Slope (%)	N/A	N/A	DWS Length (in)	N/A
N/A	Landing X Slope (%)	N/A	N/A	DWS Full Width?	N/A
N/A	Landing Curb? (Y/N)	N/A	N/A	DWS Offset (in)	N/A
N/A	Shared Landing?	N/A			
N/A	Gutter Ponding?	N/A	N/A	Gutter Slope (%)	N/A
N/A	Gutter Lip Ht (in)	N/A	N/A	Gutter X Slope (%)	N/A
N/A	Painted X Walk1?	No	N/A	Painted X Walk2?	N/A
	X Walk 1 Direction	To N		X Walk 2 Direction	N/A
N/A	X Walk 1 Width (in)	N/A	N/A	X Walk 2 Width (in)	N/A
	X Walk 1 Slope (%)	0.6		X Walk 2 Slope (%)	N/A
	X Walk 1 X Slope (%)	1.1		X Walk 2 X Slope (%)	N/A

N/A	Ramp inside XWalk1?	N/A	N/A	Ramp inside XWalk2?	N/A
	Road Slope (%)	N/A	N/A	Clear Space?	N/A
	Road X Slope (%)	N/A	N/A	Clear Space to XWalk (in)	N/A
N/A	Any Obstructions?	N/A	N/A	Storm Grate/Utility Hazard?	N/A
	Obstruction Type			Storm Grate/Utility Type	
		N/A			N/A
		Yes		Surface Condition? (G/P)	Good

**Remove & Replace Entire Ramp.**
