Access Compliance Report

Public Rights-of-Way

(Curb Ramps)

Intersection ID: 44449	Main Street: BAYVIEW_PY	Cross Street: PRESTBURY_BV	Location:	N
ADA ID: E5DCA2F028E2	Ramp Type: BlendTrans1	Initial Pass/Fail: Fail	Overall Compliance: No	Severity Score: 10

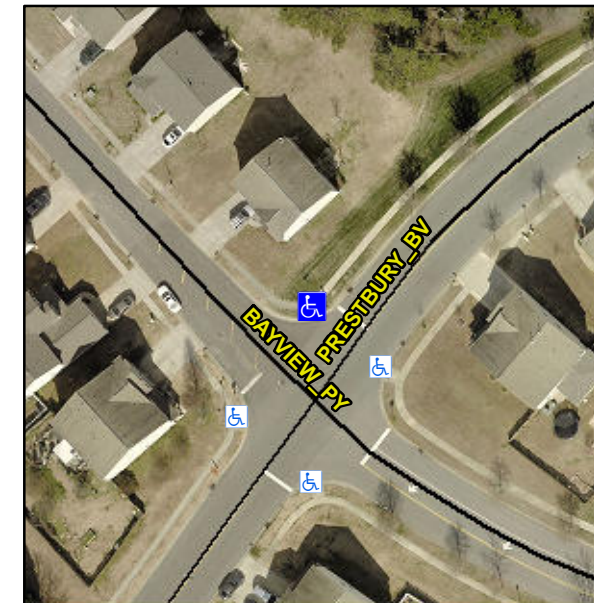
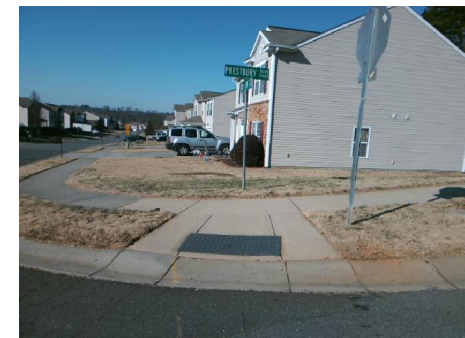
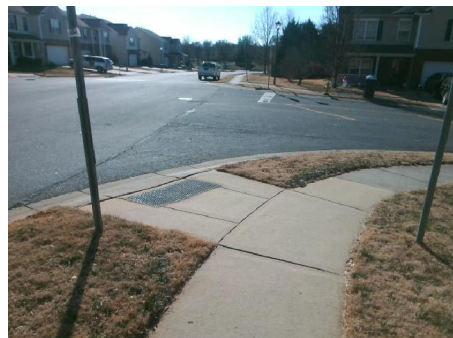
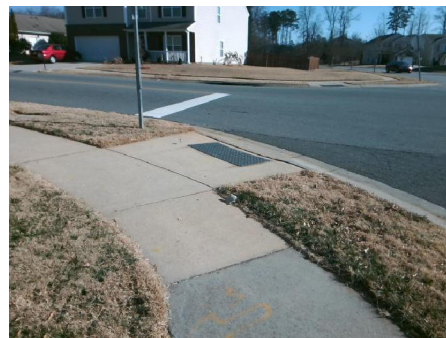
Not Found, R304.5.1, R304.5.3

Compliance	Description	Data	Compliance	Description	Data
N/A	Ramp Length (in)	64.0	Yes	BlendTrans Slope (%)	2.9
No	Ramp Width (in)	36.0	No	BlendTrans XSlope (%)	3.1
N/A	Flare Type LT	N/A	N/A	Flare Type RT	N/A
N/A	Flare Slope LT (%)	N/A	N/A	Flare Slope RT (%)	N/A
N/A	Flare Traversable LT?	N/A	N/A	Flare Traversable RT?	N/A
N/A	Landing Length (in)	N/A	N/A	DWS Provided?	N/A
N/A	Landing Width (in)	N/A	N/A	DWS Contrast?	N/A
N/A	Landing Slope (%)	N/A	N/A	DWS Length (in)	N/A
N/A	Landing X Slope (%)	N/A	N/A	DWS Full Width?	N/A
N/A	Landing Curb? (Y/N)	N/A	N/A	DWS Offset (in)	N/A
N/A	Shared Landing?	N/A			
N/A	Gutter Ponding?	N/A	N/A	Gutter Slope (%)	N/A
N/A	Gutter Lip Ht (in)	N/A	N/A	Gutter X Slope (%)	N/A
N/A	Painted X Walk1?	No	N/A	Painted X Walk2?	No
	X Walk 1 Direction	To SW		X Walk 2 Direction	To SE
	X Walk 1 Width (in)	N/A		X Walk 2 Width (in)	N/A
	X Walk 1 Slope (%)	2.4		X Walk 2 Slope (%)	1.8
	X Walk 1 X Slope (%)	1.2		X Walk 2 X Slope (%)	1.8

N/A	Ramp inside XWalk1?	N/A	N/A	Ramp inside XWalk2?	N/A
	Road Slope (%)	0.4		Clear Space?	N/A
	Road X Slope (%)	3.4	N/A	Clear Space to XWalk (in)	N/A
N/A	Any Obstructions?	N/A	N/A	Storm Grate/Utility Hazard?	N/A
	Obstruction Type			Storm Grate/Utility Type	
		N/A			N/A
			Yes	Surface Condition? (G/P)	Good
			No	Curb Slope (%)	9.5

Remove & Replace Curb Ramp With Two New Directional Ramps or Equivalent.
