Access Compliance Report

Public Rights-of-Way (Curb Ramps)

Intersection ID: N/A	Main Street: CAMPBELL_DR	Cross Street: GREENBOOK_DR	Location: E
ADA ID: E5EE319F5CF6	Ramp Type: Combination2Diag	Initial Pass/Fail: Pass	Overall Compliance: No
		Severity Score: 7.5

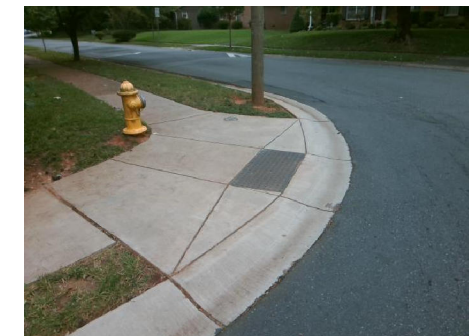
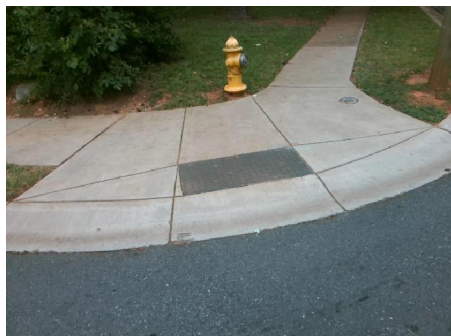
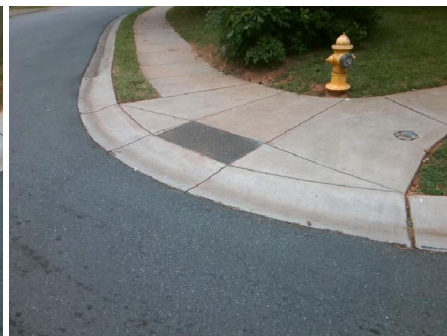
Not Found, R304.2.1, R304.2.2-Perp, R304.3.2-Para, R304.5.3, R302.7.2

Compliance	Description	Data	Compliance	Description	Data
N/A	Ramp Length LT (in)	34.0	N/A	Ramp Length RT (in)	20.0
Yes	Ramp Width LT (in)	70.0	Yes	Ramp Width RT (in)	53.0
Yes	Ramp Slope LT (%)	4.7	Yes	Ramp Slope RT (%)	5.2
Yes	Ramp XSlope LT (%)	1.5	Yes	Ramp XSlope RT (%)	1.2
N/A	Ramp Length (in)	24.0	Yes	Ramp Slope (%)	2.2
Yes	Ramp Width (in)	48.0	Yes	Ramp XSlope (%)	1.6
N/A	Flare Type LT	Sloped	N/A	Flare Type RT	Sloped
Yes	Flare Slope LT (%)	1.1	Yes	Flare Slope RT (%)	4.9
N/A	Flare Traversable LT?	Yes	N/A	Flare Traversable RT?	Yes
Yes	Landing Length (in)	70.0	Yes	DWS Provided?	Yes
No	Landing Width (in)	39.5	Yes	DWS Contrast?	Yes
No	Landing Slope (%)	3.9	Yes	DWS Length (in)	24.0
No	Landing X Slope (%)	4.1	Yes	DWS Full Width?	Yes
N/A	Landing Curb? (Y/N)	No	Yes	DWS Offset (in)	0.0
N/A	Shared Landing?	Yes			
Yes	Gutter Ponding?	No	Yes	Gutter Slope (%)	0.6
No	Gutter Lip Ht (in)	0.5	No	Gutter X Slope (%)	2.4
N/A	Painted X Walk1?	No	N/A	Painted X Walk2?	No

Remove & Replace Curb Ramp With Two New Directional Ramps or Equivalent. Remove & Replace Gutter.
