Access Compliance Report

Public Rights-of-Way

(Curb Ramps)

Intersection ID: 50607	Main Street: DENBUR_DR	Cross Street: STREAM_ORCHID_LN	Location: NE
ADA ID: E60087C929B5	Ramp Type: Perp	Initial Pass/Fail: Fail	Overall Compliance: No
		Severity Score: 8.75

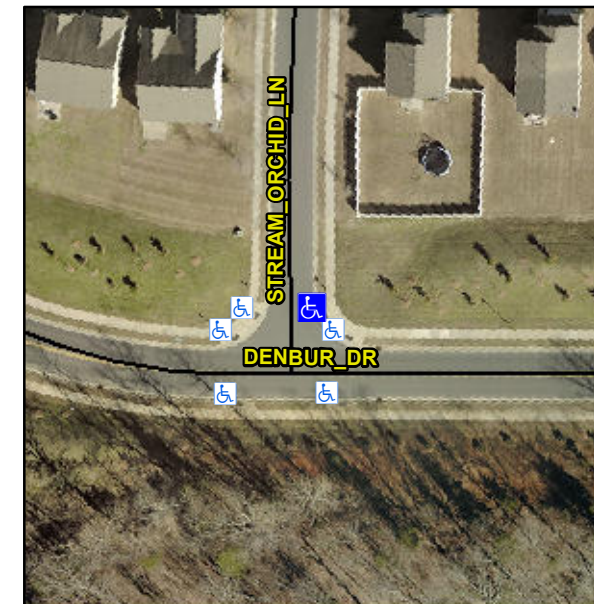
Not Found, R304.5.1

Compliance	Description	Data	Compliance	Description	Data
N/A	Ramp Length (in)	47.5	Yes	Ramp Slope (%)	6.8
No	Ramp Width (in)	47.0	Yes	Ramp XSlope (%)	1.9
N/A	Flare Type LT	N/A	N/A	Flare Type RT	N/A
N/A	Flare Slope LT (%)	N/A	N/A	Flare Slope RT (%)	N/A
N/A	Flare Traversable LT?	N/A	N/A	Flare Traversable RT?	N/A
N/A	Landing Length (in)	N/A	N/A	DWS Provided?	N/A
N/A	Landing Width (in)	N/A	N/A	DWS Contrast?	N/A
N/A	Landing Slope (%)	N/A	N/A	DWS Length (in)	N/A
N/A	Landing X Slope (%)	N/A	N/A	DWS Full Width?	N/A
N/A	Landing Curb? (Y/N)	N/A	N/A	DWS Offset (in)	N/A
N/A	Shared Landing?	N/A			
N/A	Gutter Ponding?	N/A	N/A	Gutter Slope (%)	N/A
N/A	Gutter Lip Ht (in)	N/A	N/A	Gutter X Slope (%)	N/A
N/A	Painted X Walk1?	No	N/A	Painted X Walk2?	N/A
	X Walk 1 Direction	To W		X Walk 2 Direction	N/A
N/A	X Walk 1 Width (in)	N/A	N/A	X Walk 2 Width (in)	N/A
	X Walk 1 Slope (%)	2.0		X Walk 2 Slope (%)	N/A
	X Walk 1 X Slope (%)	0.6		X Walk 2 X Slope (%)	N/A

Remove & Replace Entire Ramp.
