## Access Compliance Report Public Rights-of-Way (Curb Ramps)

Intersection ID: 6141Main Street: CATHEY\_RDCross Street: ENWOOD\_DRLocation:NADA ID: E6335C11BBA5Ramp Type: PerpInitial Pass/Fail: FailOverall Compliance: NoSeverity Score: 33.75

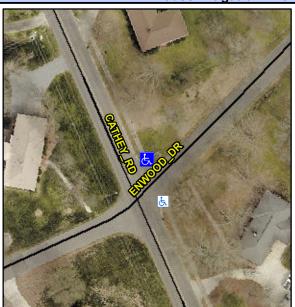
Field Measurements/Component Compliance							
Compliance Description		Data	Comp	liance Description	Data		
N/A	Ramp Length (in)	48.5	No	Ramp Slope (%)	8.6		
No	Ramp Width (in)	46.5	No	Ramp XSlope (%)	5.6		
N/A	Flare Type LT	N/A	N/A	Flare Type RT	N/A		
N/A	Flare Slope LT (%)	N/A	N/A	Flare Slope RT (%)	N/A		
N/A	Flare Traversable LT?	N/A	N/A	Flare Traversable RT?	N/A		
N/A	Landing Length (in)	N/A	N/A	DWS Provided?	N/A		
N/A	Landing Width (in)	N/A	N/A	DWS Contrast?	N/A		
N/A	Landing Slope (%)	N/A	N/A	DWS Length (in)	N/A		
N/A	Landing X Slope (%)	N/A	N/A	DWS Full Width?	N/A		
N/A	Landing Curb? (Y/N)	N/A	N/A	DWS Offset (in)	N/A		
N/A	Shared Landing?	N/A					
N/A	Gutter Ponding?	N/A	N/A	Gutter Slope (%)	N/A		
N/A	Gutter Lip Ht (in)	N/A	N/A	Gutter X Slope (%)	N/A		
N/A	Painted X Walk1?	No	N/A	Painted X Walk2?	N/A		
	X Walk 1 Direction	To S		X Walk 2 Direction	N/A		
N/A	X Walk 1 Width (in)	N/A	N/A	X Walk 2 Width (in)	N/A

X Walk 1 Slope (%)	1.1		X Walk 2 Slope (%)	N/A		
	X Walk 1 X Slope (%)	5.0		X Walk 2 X Slope (%)	N/A		
N/A	Ramp inside XWalk1?	N/A	N/A	Ramp inside XWalk2?	N/A		
	Road Slope (%)	N/A	N/A	Clear Space?	N/A		
	Road X Slope (%)	N/A	N/A	Clear Space to XWalk (in)	N/A		
N/A	Any Obstructions?	N/A	N/A	Storm Grate/Utility Hazard?	N/A		
	Obstruction Type			Storm Grate/Utility Type			
		N/A			N/A		
			Yes	Surface Condition? (G/P)	Good

Possible Solutions:				
Remove & Replace Entire Ramp.				
	ı			
	ı			
	I			
	ı			
Surveyor Notes:	 			
N/A	ı			
	ı			
	ı			
	I			
PROW/ADA:	I			
Not Found, R304.5.1, R304.2.2,				
R304.5.3	ı			
	'

Total Cost: \$ 1850.00
