Access Compliance Report

Public Rights-of-Way

(Curb Ramps)

Intersection ID: 50315	Main Street: PORTOLA_CT	Cross Street: ESMERALDA_DR	Location: SE
ADA ID: E66750D28E6D	Ramp Type: PerpDiag	Initial Pass/Fail: Fail	Overall Compliance: No
Severity Score: 10			
Codes/Mitigation Info/Possible Solution		Field Measurements/Component Compliance

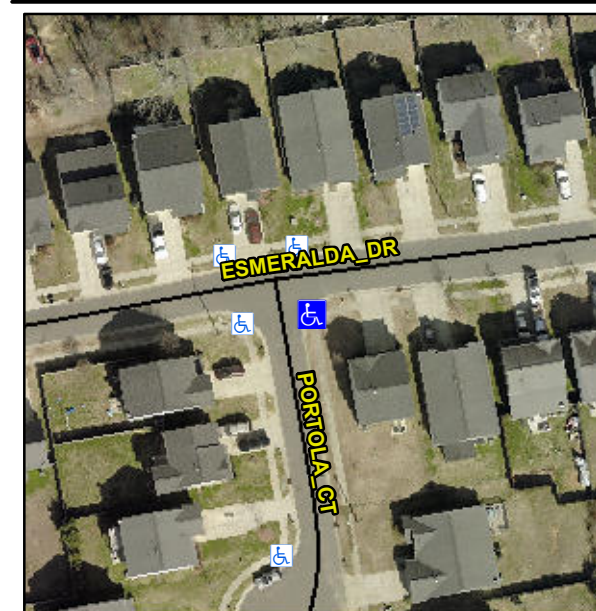
Not Found, R304.5.1, R304.5.3

Compliance	Description	Data	Compliance	Description	Data
N/A	Ramp Length (in)	49.0	Yes	Ramp Slope (%)	7.0
No	Ramp Width (in)	41.5	No	Ramp XSlope (%)	3.5
N/A	Flare Type LT	N/A	N/A	Flare Type RT	N/A
N/A	Flare Slope LT (%)	N/A	N/A	Flare Slope RT (%)	N/A
N/A	Flare Traversable LT?	N/A	N/A	Flare Traversable RT?	N/A
N/A	Landing Length (in)	N/A	N/A	DWS Provided?	N/A
N/A	Landing Width (in)	N/A	N/A	DWS Contrast?	N/A
N/A	Landing Slope (%)	N/A	N/A	DWS Length (in)	N/A
N/A	Landing X Slope (%)	N/A	N/A	DWS Full Width?	N/A
N/A	Landing Curb? (Y/N)	N/A	N/A	DWS Offset (in)	N/A
N/A	Shared Landing?	N/A			
N/A	Gutter Ponding?	N/A	N/A	Gutter Slope (%)	N/A
N/A	Gutter Lip Ht (in)	1.0	N/A	Gutter X Slope (%)	N/A
N/A	Painted X Walk1?	No	N/A	Painted X Walk2?	No
	X Walk 1 Direction	To N		X Walk 2 Direction	To W
N/A	X Walk 1 Width (in)	N/A	N/A	X Walk 2 Width (in)	N/A
	X Walk 1 Slope (%)	3.2		X Walk 2 Slope (%)	0.7
	X Walk 1 X Slope (%)	2.1		X Walk 2 X Slope (%)	5.4

N/A	Ramp inside XWalk1?	N/A	N/A	Ramp inside XWalk2?	N/A
	Road Slope (%)	5.5	N/A	Clear Space?	N/A
	Road X Slope (%)	1.9	N/A	Clear Space to XWalk (in)	N/A
N/A	Any Obstructions?	N/A	N/A	Storm Grate/Utility Hazard?	N/A
	Obstruction Type			Storm Grate/Utility Type	
		N/A			N/A
		Yes		Surface Condition? (G/P)	Good

Possible Solutions:

Remove & Replace Curb Ramp With Two New Directional Ramps or Equivalent.
