Access Compliance Report Public Rights-of-Way (Curb Ramps)

Intersection ID: 2956 Main Street: COTTAGE_OAKS_DR Cross Street: JOHNSTON_MILL_CT Location: NW

ADA ID: E668F7CBEBF6 Ramp Type: BlendTrans1 Initial Pass/Fail: Pass Overall Compliance: No Severity Score: 7.5

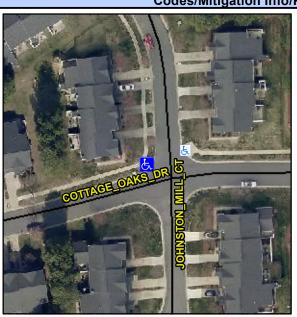
Not Found, R304.2.2-Perp, R304.3.2-Para, R305.1.4, R305.2, R304.5.4

Remove & Replace Curb Ramp With Two New Directional Ramps or Equivalent. Remove & Replace Gutter.
