## **Access Compliance Report Public Rights-of-Way** (Curb Ramps)

Intersection ID: 26766 Main Street: SETON\_HOUSE\_LN Cross Street: N/A Location: SW ADA ID: E6A866BD328B **Overall Compliance: No** Ramp Type: Perp Initial Pass/Fail: Fail Severity Score: 21.25

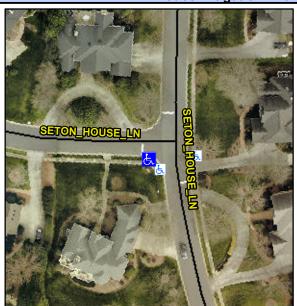
Field Measurements/Component Compliance							
Comp	liance Description	Data	Comp	liance Description	Data		
N/A	Ramp Length (in)	48.0	No	Ramp Slope (%)	8.7		
No	Ramp Width (in)	40.5	Yes	Ramp XSlope (%)	1.6		
N/A	Flare Type LT	N/A	N/A	Flare Type RT	N/A		
N/A	Flare Slope LT (%)	N/A	N/A	Flare Slope RT (%)	N/A		
N/A	Flare Traversable LT?	N/A	N/A	Flare Traversable RT?	N/A		
N/A	Landing Length (in)	N/A	N/A	DWS Provided?	N/A		
N/A	Landing Width (in)	N/A	N/A	DWS Contrast?	N/A		
N/A	Landing Slope (%)	N/A	N/A	DWS Length (in)	N/A		
N/A	Landing X Slope (%)	N/A	N/A	DWS Full Width?	N/A		
N/A	Landing Curb? (Y/N)	N/A	N/A	DWS Offset (in)	N/A		
N/A	Shared Landing?	N/A					
N/A	Gutter Ponding?	N/A	N/A	Gutter Slope (%)	N/A		
N/A	Gutter Lip Ht (in)	N/A	N/A	Gutter X Slope (%)	N/A		
N/A	Painted X Walk1?	No	N/A	Painted X Walk2?	N/A		
	X Walk 1 Direction	To N		X Walk 2 Direction	N/A		
N/A	X Walk 1 Width (in)	N/A	N/A	X Walk 2 Width (in)	N/A

Possible Solutions:	9
Remove & Replace Entire Ramp.	1
	1
	1
	ı
	ı
	ı
Surveyor Notes:	ı
N/A	1
	ı
	ı
	ı
PROW/ADA:	ı
Not Found, R304.5.1, R304.2.2	N
	ı
	ı
	ı
