Access Compliance Report

Public Rights-of-Way

(Curb Ramps)

Intersection ID: 10018128	Main Street: LIGON_CT	Cross Street: N/A	Location:	N
ADA ID: E6BBBD6A8DE9	Ramp Type: Perp	Initial Pass/Fail: Fail	Overall Compliance: No	Severity Score: 22.5
Codes/Mitigation Info/Possible Solution		Field Measurements/Component Compliance

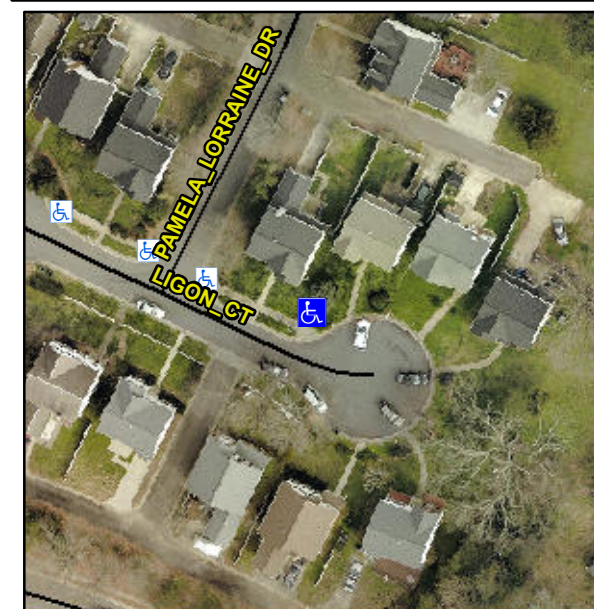
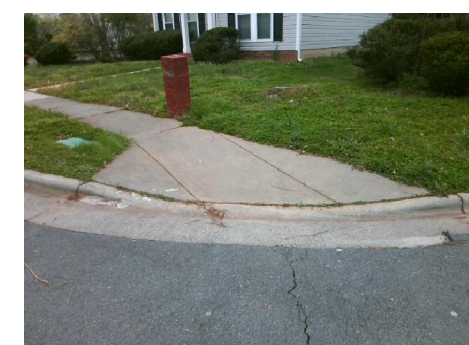
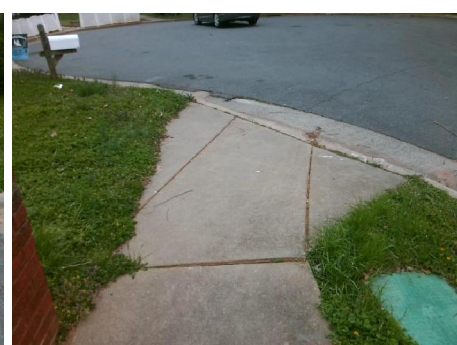
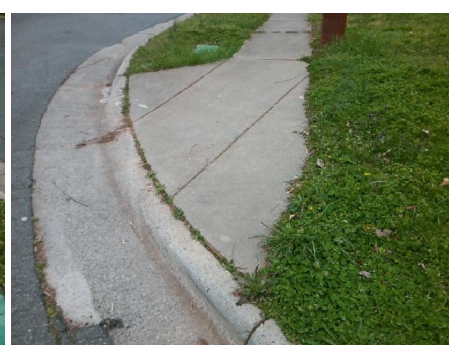
Not Found, R304.5.1, R304.2.2, R304.5.3

Compliance	Description	Data	Compliance	Description	Data
N/A	Ramp Length (in)	87.0	No	Ramp Slope (%)	9.7
No	Ramp Width (in)	45.0	No	Ramp XSlope (%)	2.5
N/A	Flare Type LT	N/A	N/A	Flare Type RT	N/A
N/A	Flare Slope LT (%)	N/A	N/A	Flare Slope RT (%)	N/A
N/A	Flare Traversable LT?	N/A	N/A	Flare Traversable RT?	N/A
N/A	Landing Length (in)	N/A	N/A	DWS Provided?	N/A
N/A	Landing Width (in)	N/A	N/A	DWS Contrast?	N/A
N/A	Landing Slope (%)	N/A	N/A	DWS Length (in)	N/A
N/A	Landing X Slope (%)	N/A	N/A	DWS Full Width?	N/A
N/A	Landing Curb? (Y/N)	N/A	N/A	DWS Offset (in)	N/A
N/A	Shared Landing?	N/A			
N/A	Gutter Ponding?	N/A	N/A	Gutter Slope (%)	N/A
N/A	Gutter Lip Ht (in)	N/A	N/A	Gutter X Slope (%)	N/A
N/A	Painted X Walk1?	No	N/A	Painted X Walk2?	N/A
	X Walk 1 Direction	To S		X Walk 2 Direction	N/A
N/A	X Walk 1 Width (in)	N/A	N/A	X Walk 2 Width (in)	N/A
	X Walk 1 Slope (%)	2.2		X Walk 2 Slope (%)	N/A
	X Walk 1 X Slope (%)	2.1		X Walk 2 X Slope (%)	N/A

Remove & Replace Entire Ramp.
