Access Compliance Report

Public Rights-of-Way

(Curb Ramps)

Intersection ID: 28156	Main Street: ARBOR GROVE LN	Cross Street: OLIVIA LN	Location: NW
ADA ID: E6DE6EB2C1A6	Ramp Type: PerpDiag	Initial Pass/Fail: Fail	Overall Compliance: No
		Severity Score: 60

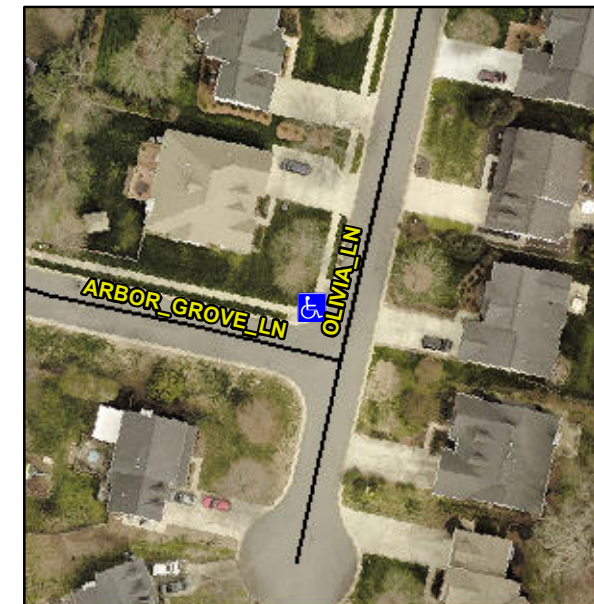
Not Found, R304.5.1, R304.2.2, R304.5.3

Compliance	Description	Data	Compliance	Description	Data
N/A	Ramp Length (in)	95.5	No	Ramp Slope (%)	8.4
No	Ramp Width (in)	25.0	No	Ramp XSlope (%)	6.1
N/A	Flare Type LT	N/A	N/A	Flare Type RT	N/A
N/A	Flare Slope LT (%)	N/A	N/A	Flare Slope RT (%)	N/A
N/A	Flare Traversable LT?	N/A	N/A	Flare Traversable RT?	N/A
N/A	Landing Length (in)	N/A	N/A	DWS Provided?	N/A
N/A	Landing Width (in)	N/A	N/A	DWS Contrast?	N/A
N/A	Landing Slope (%)	N/A	N/A	DWS Length (in)	N/A
N/A	Landing X Slope (%)	N/A	N/A	DWS Full Width?	N/A
N/A	Landing Curb? (Y/N)	N/A	N/A	DWS Offset (in)	N/A
N/A	Shared Landing?	N/A			
N/A	Gutter Ponding?	N/A	N/A	Gutter Slope (%)	N/A
N/A	Gutter Lip Ht (in)	N/A	N/A	Gutter X Slope (%)	N/A
N/A	Painted X Walk1?	No	N/A	Painted X Walk2?	No
	X Walk 1 Direction	To SW		X Walk 2 Direction	To SE
N/A	X Walk 1 Width (in)	N/A	N/A	X Walk 2 Width (in)	N/A
	X Walk 1 Slope (%)	3.6		X Walk 2 Slope (%)	2.9
	X Walk 1 X Slope (%)	4.0		X Walk 2 X Slope (%)	3.2

N/A	Ramp inside XWalk1?	N/A	N/A	Ramp inside XWalk2?	N/A
	Road Slope (%)	5.5	N/A	Clear Space?	N/A
	Road X Slope (%)	1.7	N/A	Clear Space to XWalk (in)	N/A
N/A	Any Obstructions?	N/A	N/A	Storm Grate/Utility Hazard?	N/A
	Obstruction Type			Storm Grate/Utility Type	
		N/A			N/A
			Yes	Surface Condition? (G/P)	Good

Remove & Replace Curb Ramp With Two New Directional Ramps or Equivalent.
