# Access Compliance Report

## Public Rights-of-Way

### (Curb Ramps)

Intersection ID: 45173	Main Street: LINDEN_TREE_LN	Cross Street: MAPLEHURST_DR	Location: NE
ADA ID: E78BD0971A93	Ramp Type: PerpDiag	Initial Pass/Fail: Fail	Overall Compliance: No
Severity Score: 21.25			
Codes/Mitigation Info/Possible Solution		Field Measurements/Component Compliance

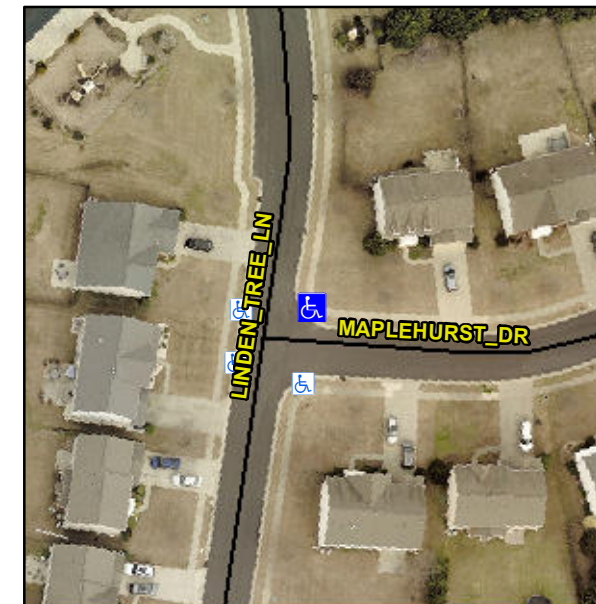
**Not Found, R304.5.1, R304.2.2**

Compliance	Description	Data	Compliance	Description	Data
N/A	Ramp Length (in)	48.0	No	Ramp Slope (%)	8.5
No	Ramp Width (in)	47.0	Yes	Ramp XSlope (%)	1.4
N/A	Flare Type LT	N/A	N/A	Flare Type RT	N/A
N/A	Flare Slope LT (%)	N/A	N/A	Flare Slope RT (%)	N/A
N/A	Flare Traversable LT?	N/A	N/A	Flare Traversable RT?	N/A
N/A	Landing Length (in)	N/A	N/A	DWS Provided?	N/A
N/A	Landing Width (in)	N/A	N/A	DWS Contrast?	N/A
N/A	Landing Slope (%)	N/A	N/A	DWS Length (in)	N/A
N/A	Landing X Slope (%)	N/A	N/A	DWS Full Width?	N/A
N/A	Landing Curb? (Y/N)	N/A	N/A	DWS Offset (in)	N/A
N/A	Shared Landing?	N/A			
N/A	Gutter Ponding?	N/A	N/A	Gutter Slope (%)	N/A
N/A	Gutter Lip Ht (in)	N/A	N/A	Gutter X Slope (%)	N/A
N/A	Painted X Walk1?	No	N/A	Painted X Walk2?	No
	X Walk 1 Direction	To NW		X Walk 2 Direction	To SW
N/A	X Walk 1 Width (in)	N/A	N/A	X Walk 2 Width (in)	N/A
	X Walk 1 Slope (%)	1.8		X Walk 2 Slope (%)	0.1
	X Walk 1 X Slope (%)	2.3		X Walk 2 X Slope (%)	1.9

**Remove & Replace Curb Ramp With Two New Directional Ramps or Equivalent.**

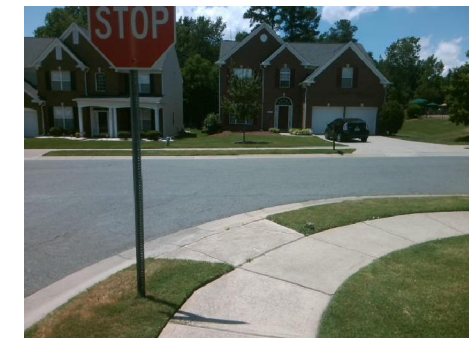
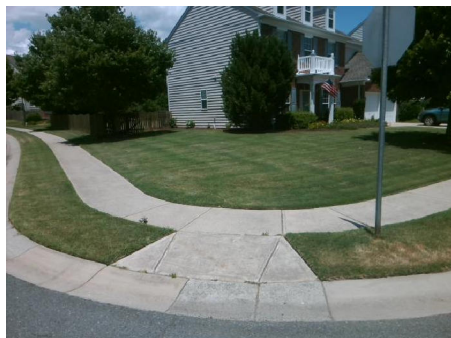
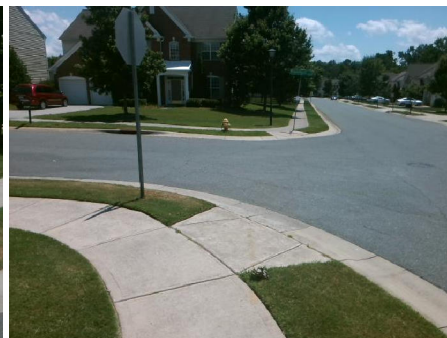
N/A	Ramp inside XWalk1?	N/A	N/A	Ramp inside XWalk2?	N/A
	Road Slope (%)	1.2	N/A	Clear Space?	N/A
	Road X Slope (%)	0.5	N/A	Clear Space to XWalk (in)	N/A
N/A	Any Obstructions?	N/A	N/A	Storm Grate/Utility Hazard?	N/A
	Obstruction Type			Storm Grate/Utility Type	
		N/A			N/A
		Yes		Surface Condition? (G/P)	Good
