Access Compliance Report

Public Rights-of-Way

(Curb Ramps)

Intersection ID: 5291	Main Street: LEX_DR	Cross Street: MARY_ALEXANDER_RD	Location: E
ADA ID: E7B94FA9293D	Ramp Type: Para	Initial Pass/Fail: Pass	Overall Compliance: No
Severity Score: 5			
Codes/Mitigation Info/Possible Solution		Field Measurements/Component Compliance

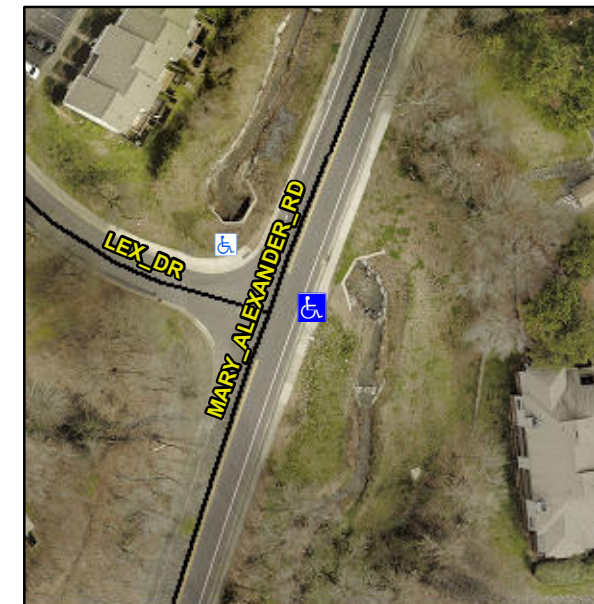
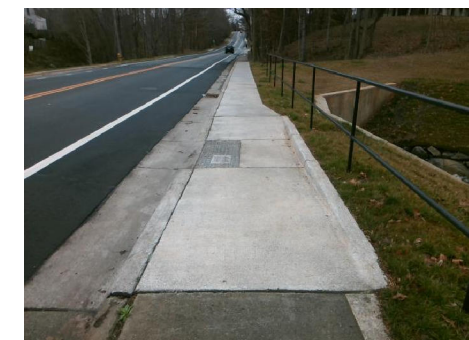
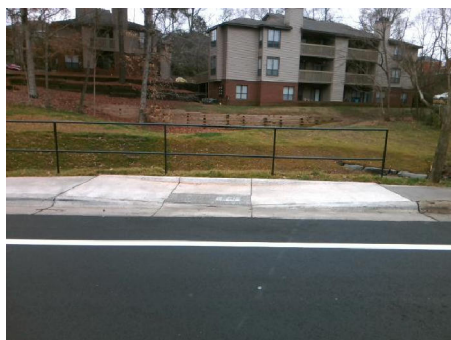
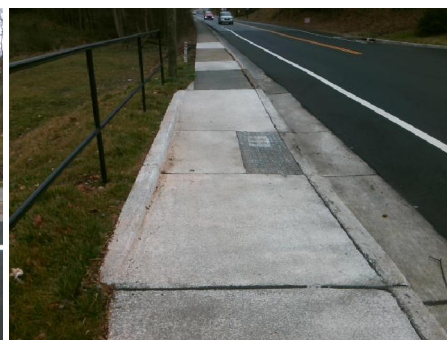
RT RP < 5%

Not Found, R304.5.4

Compliance	Description	Data	Compliance	Description	Data
N/A	Ramp Length LT (in)	69.5	N/A	Ramp Length RT (in)	104.5
Yes	Ramp Width LT (in)	60.0	Yes	Ramp Width RT (in)	60.0
Yes	Ramp Slope LT (%)	5.2	Yes	Ramp Slope RT (%)	4.3
Yes	Ramp XSlope LT (%)	1.7	Yes	Ramp XSlope RT (%)	0.4
Yes	Landing Length (in)	60.0	Yes	DWS Provided?	Yes
Yes	Landing Width (in)	60.0	Yes	DWS Contrast?	Yes
Yes	Landing Slope (%)	0.6	Yes	DWS Length (in)	24.0
Yes	Landing X Slope (%)	0.7	Yes	DWS Full Width?	Yes
N/A	Landing Curb? (Y/N)	Yes	Yes	DWS Offset (in)	0.0
N/A	Shared Landing?	No			
Yes	Gutter Ponding?	No	No	Gutter Slope (%)	6.3
Yes	Gutter Lip Ht (in)	0.0	Yes	Gutter X Slope (%)	1.7
N/A	Painted X Walk1?	No	N/A	Painted X Walk2?	N/A
	X Walk 1 Direction	To NW		X Walk 2 Direction	N/A
N/A	X Walk 1 Width (in)	N/A	N/A	X Walk 2 Width (in)	N/A
	X Walk 1 Slope (%)	4.6		X Walk 2 Slope (%)	N/A
	X Walk 1 X Slope (%)	2.2		X Walk 2 X Slope (%)	N/A
N/A	Ramp inside XWalk1?	N/A	N/A	Ramp inside XWalk2?	N/A

Road Slope (%)	N/A	N/A	Clear Space?	Yes
	Road X Slope (%)	N/A	N/A	Clear Space to XWalk (in)	N/A
Yes	Any Obstructions?	No	Yes	Storm Grate/Utility Hazard?	No
	Obstruction Type			Storm Grate/Utility Type	
		N/A			N/A
			Yes	Surface Condition? (G/P)	Good
			Replace	Curb Slope (%)	9.8

Remove & Replace Entire Ramp.
Remove & Replace Gutter.
