Access Compliance Report Public Rights-of-Way (Curb Ramps)

Intersection ID: 43508 Main Street: MULBERRY_POND_DR Cross Street: GOOSEBERRY_RD Location: W

ADA ID: E8157ED1AB15 Ramp Type: PerpDiag Initial Pass/Fail: Fail Overall Compliance: No Severity Score: 21.25

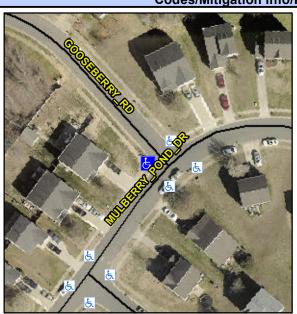
R304.5.1, R304.5.3

| Field Measurements/Component Compliance | | | | | | |
|---|---|---|---|---|---|---|
| | No | Ramp Width (in) | 46.5 | No | Ramp XSlope (%) | 6.3 |

Remove & Replace Curb Ramp With Two New Directional Ramps or Equivalent.
