Access Compliance Report

Public Rights-of-Way

(Curb Ramps)

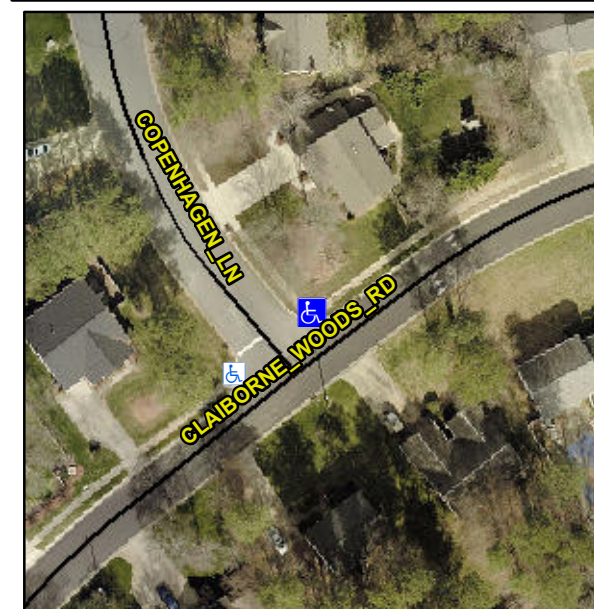
Intersection ID: 3568	Main Street: CLAIBORNE_WOODS_RD	Cross Street: COPENHAGEN_LN	Location:	N
ADA ID: E839B452DE14	Ramp Type: Perp	Initial Pass/Fail: Fail	Overall Compliance: No	Severity Score: 8.75
Codes/Mitigation Info/Possible Solution		Field Measurements/Component Compliance

Not Found, R304.5.1

Compliance	Description	Data	Compliance	Description	Data
N/A	Ramp Length (in)	96.0	Yes	Ramp Slope (%)	6.5
No	Ramp Width (in)	45.0	Yes	Ramp XSlope (%)	0.5
N/A	Flare Type LT	N/A	N/A	Flare Type RT	N/A
N/A	Flare Slope LT (%)	N/A	N/A	Flare Slope RT (%)	N/A
N/A	Flare Traversable LT?	N/A	N/A	Flare Traversable RT?	N/A
N/A	Landing Length (in)	N/A	N/A	DWS Provided?	N/A
N/A	Landing Width (in)	N/A	N/A	DWS Contrast?	N/A
N/A	Landing Slope (%)	N/A	N/A	DWS Length (in)	N/A
N/A	Landing X Slope (%)	N/A	N/A	DWS Full Width?	N/A
N/A	Landing Curb? (Y/N)	N/A	N/A	DWS Offset (in)	N/A
N/A	Shared Landing?	N/A			
N/A	Gutter Ponding?	N/A	N/A	Gutter Slope (%)	N/A
N/A	Gutter Lip Ht (in)	N/A	N/A	Gutter X Slope (%)	N/A
N/A	Painted X Walk1?	No	N/A	Painted X Walk2?	N/A
	X Walk 1 Direction	To SW		X Walk 2 Direction	N/A
N/A	X Walk 1 Width (in)	N/A	N/A	X Walk 2 Width (in)	N/A
	X Walk 1 Slope (%)	0.5		X Walk 2 Slope (%)	N/A
	X Walk 1 X Slope (%)	0.2		X Walk 2 X Slope (%)	N/A

Remove & Replace Entire Ramp.
