Access Compliance Report Public Rights-of-Way (Curb Ramps)

Intersection ID: 50738 Main Street: RUBIN_LURA_CT Cross Street: LYNN_LEE_CR Location: N **Overall Compliance: No Severity Score:** ADA ID: E846F0DDA3D9 Ramp Type: Perp Initial Pass/Fail: Fail 22.5

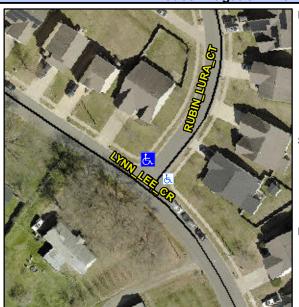
Possible Solutions:	_				
Remove & Replace Entire Ramp.					
	١				
	ľ				
Surveyor Notes:	ı				
N/A	ı				
	ı				
	ı				
PROW/ADA:					
Not Found, R304.5.1, R304.2.2, R304.5.3	1				
	•				
	ı				
	ı

Field Measurements/Component Compliance							
Compl	iance Description	Data	Comp	liance Description	Data		
N/A	Ramp Length (in)	46.0	No	Ramp Slope (%)	10.3		
No	Ramp Width (in)	45.0	No	Ramp XSlope (%)	3.6		
N/A	Flare Type LT	N/A	N/A	Flare Type RT	N/A		
N/A	Flare Slope LT (%)	N/A	N/A	Flare Slope RT (%)	N/A		
N/A	Flare Traversable LT?	N/A	N/A	Flare Traversable RT?	N/A		
N/A	Landing Length (in)	N/A	N/A	DWS Provided?	N/A		
N/A	Landing Width (in)	N/A	N/A	DWS Contrast?	N/A		
N/A	Landing Slope (%)	N/A	N/A	DWS Length (in)	N/A		
N/A	Landing X Slope (%)	N/A	N/A	DWS Full Width?	N/A		
N/A	Landing Curb? (Y/N)	N/A	N/A	DWS Offset (in)	N/A		
N/A	Shared Landing?	N/A					
N/A	Gutter Ponding?	N/A	N/A	Gutter Slope (%)	N/A		
N/A	Gutter Lip Ht (in)	N/A	N/A	Gutter X Slope (%)	N/A		
N/A	Painted X Walk1?	No	N/A	Painted X Walk2?	N/A		
	X Walk 1 Direction	To SE		X Walk 2 Direction	N/A		
N/A	X Walk 1 Width (in)	N/A	N/A	X Walk 2 Width (in)	N/A

X Walk 1 Slope (%)	1.2		X Walk 2 Slope (%)	N/A		
	X Walk 1 X Slope (%)	4.3		X Walk 2 X Slope (%)	N/A		
N/A	Ramp inside XWalk1?	N/A	N/A	Ramp inside XWalk2?	N/A		
	Road Slope (%)	N/A	N/A	Clear Space?	N/A		
	Road X Slope (%)	N/A	N/A	Clear Space to XWalk (in)	N/A		
N/A	Any Obstructions?	N/A	N/A	Storm Grate/Utility Hazard	? N/A		
	Obstruction Type			Storm Grate/Utility Type			
		N/A			N/A		
			Yes	Surface Condition? (G/P)	Good
