Access Compliance Report

Public Rights-of-Way

(Curb Ramps)

Intersection ID: 4106	Main Street: CLAYBROOKE_DR	Cross Street: TURNING_LEAF_CT	Location: NE
ADA ID: E8796E94A2BA	Ramp Type: Perp	Initial Pass/Fail: Fail	Overall Compliance: No
		Severity Score: 37.5

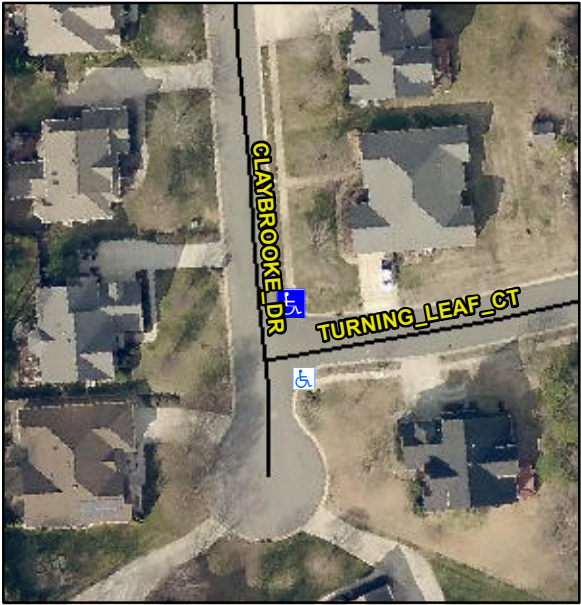
Possible Solutions:		Compliance	Description	Data
	Remove & Replace Entire Ramp.		N/A	Ramp Length (in)	96.0
			Yes	Ramp Width (in)	52.5
			N/A	Flare Type LT	N/A
			N/A	Flare Slope LT (%)	N/A
			N/A	Flare Traversable LT?	N/A
			N/A	Landing Length (in)	N/A
			N/A	Landing Width (in)	N/A
			N/A	Landing Slope (%)	N/A
			N/A	Landing X Slope (%)	N/A
<p>Surveyor Notes:</p> <p>N/A</p> <p>PROW/ADA:</p> <p>Not Found, R304.2.2, R304.5.3</p>			N/A	Flare Type RT	N/A
			N/A	Flare Slope RT (%)	N/A
			N/A	Flare Traversable RT?	N/A
			N/A	DWS Provided?	N/A
			N/A	DWS Contrast?	N/A
			N/A	DWS Length (in)	N/A
			N/A	DWS Full Width?	N/A
			N/A	DWS Offset (in)	N/A
			N/A	Shared Landing?	N/A
			N/A	Gutter Ponding?	N/A
			N/A	Gutter Lip Ht (in)	N/A
			N/A	Painted X Walk1?	No
				X Walk 1 Direction	To S
			N/A	X Walk 1 Width (in)	N/A
				X Walk 1 Slope (%)	1.4

X Walk 1 X Slope (%)	3.7
			N/A	Ramp inside XWalk1?	N/A
				Road Slope (%)	N/A
				Road X Slope (%)	N/A
			N/A	Any Obstructions?	N/A
				Obstruction Type	
Total Cost:		\$ 1850.00			
			N/A		N/A
			Yes	Surface Condition? (G/P)	Good
