# Access Compliance Report

## Public Rights-of-Way

### (Curb Ramps)

Intersection ID: 49458	Main Street: PEBBLE_RUN_DR	Cross Street: TILLEY_MORRIS_RD	Location: SE
ADA ID: E8C63D5817AF	Ramp Type: Combination1	Initial Pass/Fail: Fail	Overall Compliance: No
			Severity Score: 33.75

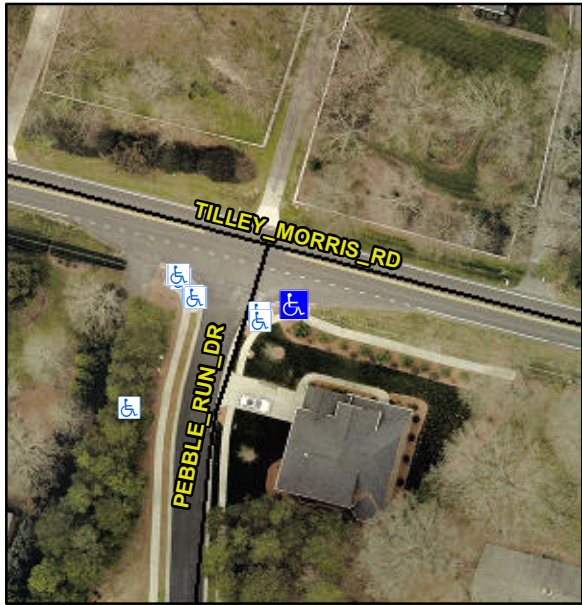
Possible Solutions:			<b>Compliance</b>	<b>Description</b>	<b>Data</b>	<b>Compliance</b>	<b>Description</b>	<b>Data</b>
	<b>Remove &amp; Replace Entire Ramp.</b>			N/A	Ramp Length LT (in)	53.0	N/A	Ramp Length RT (in)	41.0
				Yes	Ramp Width LT (in)	50.0	No	Ramp Width RT (in)	47.0
				No	Ramp Slope LT (%)	12.4	Yes	Ramp Slope RT (%)	1.3
				Yes	Ramp XSlope LT (%)	1.9	Yes	Ramp XSlope RT (%)	1.5
				N/A	Ramp Length (in)	47.0	Yes	Ramp Slope (%)	3.6
				No	Ramp Width (in)	47.5	Yes	Ramp XSlope (%)	0.1
				N/A	Flare Type LT	N/A	N/A	Flare Type RT	N/A
				N/A	Flare Slope LT (%)	N/A	N/A	Flare Slope RT (%)	N/A
				N/A	Flare Traversable LT?	N/A	N/A	Flare Traversable RT?	N/A
<p>Surveyor Notes:</p> <p><b>RP &amp; RT RP &lt; 5%</b></p> <p>PROW/ADA:</p> <p><b>Not Found, R304.5.1, R304.5.1, R304.3.2</b></p>				N/A	Landing Length (in)	N/A	N/A	DWS Provided?	N/A
