Access Compliance Report

Public Rights-of-Way

Intersection ID: 14278	Main Street: ROMARE_BEARDEN_DR	Cross Street: FARMER_ST	Location: SE
ADA ID: E9FBD2A05CCD	Ramp Type: Perp	Initial Pass/Fail: Fail	Overall Compliance: No
		Severity Score: 25

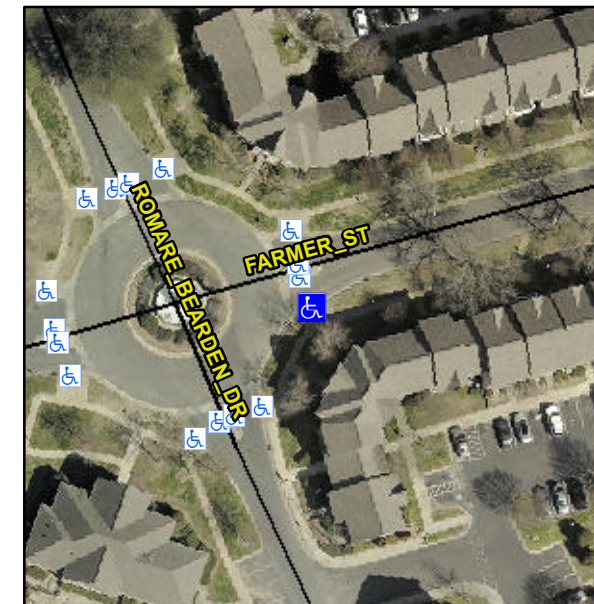
R304.2.2, R304.5.3

Compliance	Description	Data	Compliance	Description	Data
N/A	Ramp Length (in)	96.0	No	Ramp Slope (%)	8.7
Yes	Ramp Width (in)	57.0	No	Ramp XSlope (%)	6.1
N/A	Flare Type LT	N/A	N/A	Flare Type RT	N/A
N/A	Flare Slope LT (%)	N/A	N/A	Flare Slope RT (%)	N/A
N/A	Flare Traversable LT?	N/A	N/A	Flare Traversable RT?	N/A
N/A	Landing Length (in)	N/A	N/A	DWS Provided?	N/A
N/A	Landing Width (in)	N/A	N/A	DWS Contrast?	N/A
N/A	Landing Slope (%)	N/A	N/A	DWS Length (in)	N/A
N/A	Landing X Slope (%)	N/A	N/A	DWS Full Width?	N/A
N/A	Landing Curb? (Y/N)	N/A	N/A	DWS Offset (in)	N/A
N/A	Shared Landing?	N/A			
N/A	Gutter Ponding?	N/A	N/A	Gutter Slope (%)	N/A
N/A	Gutter Lip Ht (in)	N/A	N/A	Gutter X Slope (%)	N/A
N/A	Painted X Walk1?	No	N/A	Painted X Walk2?	N/A
	X Walk 1 Direction	To N		X Walk 2 Direction	N/A
N/A	X Walk 1 Width (in)	N/A	N/A	X Walk 2 Width (in)	N/A
	X Walk 1 Slope (%)	0.2		X Walk 2 Slope (%)	N/A
	X Walk 1 X Slope (%)	4.3		X Walk 2 X Slope (%)	N/A

Remove & Replace Entire Ramp.
