Access Compliance Report

Public Rights-of-Way (Curb Ramps)

Intersection ID: 12937	Main Street: E_W_T_HARRIS_BV	Cross Street: HICKORY_GROVE_RD	Location: SE
ADA ID: EA0F34DBFB37	Ramp Type: Combination1	Initial Pass/Fail: Fail	Overall Compliance: No
			Severity Score: 33.75

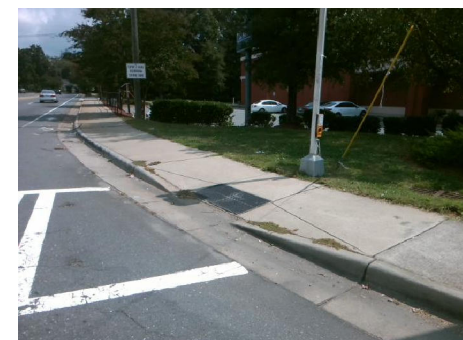
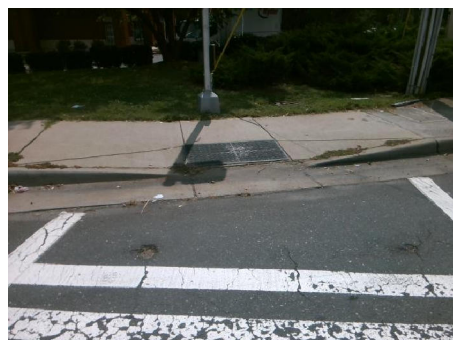
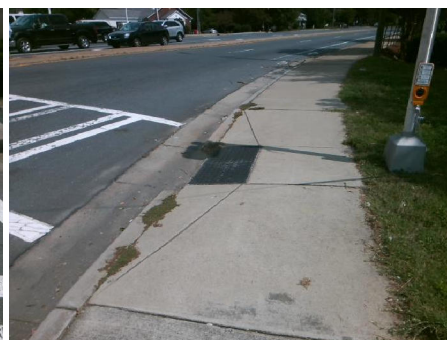
RT RP < 5%

Not Found, R304.5.1, R304.5.1, R304.2.2

Remove & Replace Entire Ramp.
