| Intersection ID: 11357 | Main Street: W_TRADE_ST | Cross Street: JOHNSON_AND_WALES_WY | Location: | W |
| ADA ID: EA2045ABD1E6 | Ramp Type: BlendTrans1 | Initial Pass/Fail: Pass | Overall Compliance: No | Severity Score: 15.25 |

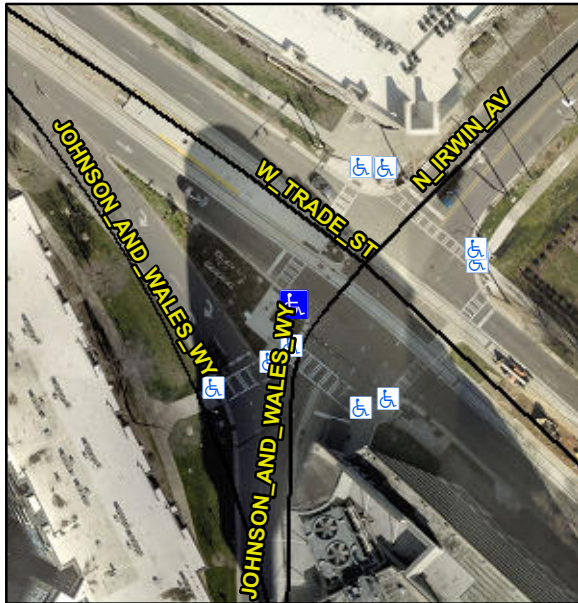
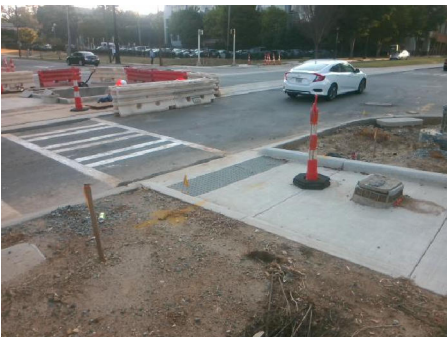
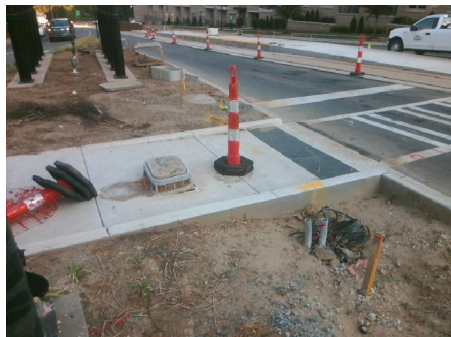
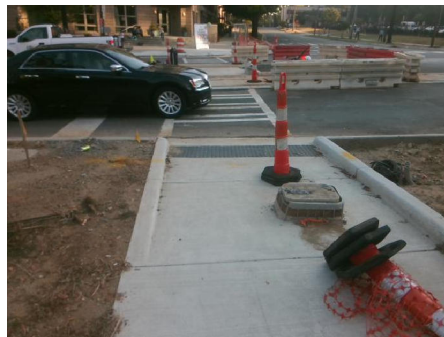
**LOCATED ON ISLAND**

| Compliance | Description | Data | Compliance | Description | Data |
|---|---|---|---|---|---|
| No | Gutter Lip Ht (in) | 1.0 | Yes | Gutter X Slope (%) | 3.8 |
| PULLBOX LIP 9.5 | | | | | N/A |

**Grind Gutter Lip. Utility Present.**

**R302.7.2, R302.3, R402.2**

Total Cost: \$ 5200.00
