Access Compliance Report

Public Rights-of-Way

(Curb Ramps)

Intersection ID: 28305	Main Street: COMMUNITY HOUSE RD	Cross Street: TAMARACK DR	Location:	N
ADA ID: EA5E982B9D4A	Ramp Type: Combination1Diag	Initial Pass/Fail: Fail	Overall Compliance: No	Severity Score: 0

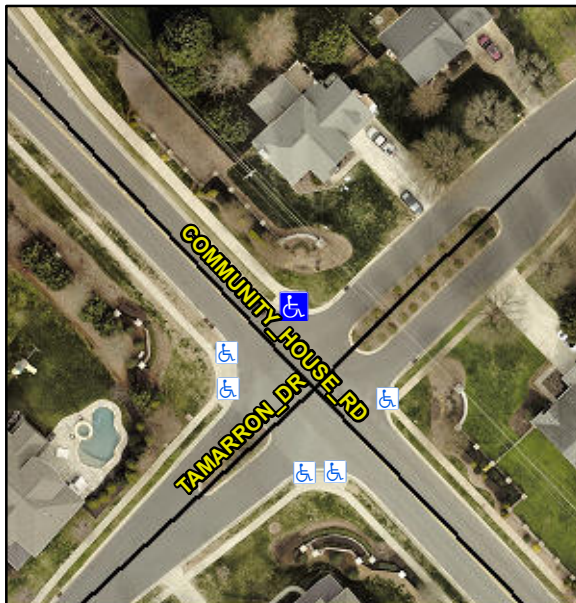
RP < 5 %, CURB WIDTH 44.0

R304.5.1, R304.5.3

Compliance	Description	Data	Compliance	Description	Data
N/A	Ramp Length LT (in)	41.0	N/A	Ramp Length RT (in)	48.0
Yes	Ramp Width LT (in)	70.0	Yes	Ramp Width RT (in)	71.0
Yes	Ramp Slope LT (%)	7.0	Yes	Ramp Slope RT (%)	7.1
Yes	Ramp XSlope LT (%)	1.5	No	Ramp XSlope RT (%)	2.8
N/A	Ramp Length (in)	48.0	Yes	Ramp Slope (%)	4.7
No	Ramp Width (in)	47.0	Yes	Ramp XSlope (%)	0.5
N/A	Flare Type LT	N/A	N/A	Flare Type RT	N/A
N/A	Flare Slope LT (%)	N/A	N/A	Flare Slope RT (%)	N/A
N/A	Flare Traversable LT?	N/A	N/A	Flare Traversable RT?	N/A
N/A	Landing Length (in)	N/A	N/A	DWS Provided?	N/A
N/A	Landing Width (in)	N/A	N/A	DWS Contrast?	N/A
N/A	Landing Slope (%)	N/A	N/A	DWS Length (in)	N/A
N/A	Landing X Slope (%)	N/A	N/A	DWS Full Width?	N/A
N/A	Landing Curb? (Y/N)	N/A	N/A	DWS Offset (in)	N/A
N/A	Shared Landing?	N/A			
N/A	Gutter Ponding?	N/A	N/A	Gutter Slope (%)	N/A
N/A	Gutter Lip Ht (in)	N/A	N/A	Gutter X Slope (%)	N/A
N/A	Painted X Walk1?	No	N/A	Painted X Walk2?	No

Remove & Replace Curb Ramp With Two New Directional Ramps or Equivalent.
