Access Compliance Report

Public Rights-of-Way

(Curb Ramps)

Intersection ID: 8615	Main Street: DARBY_AV	Cross Street: NELSON_AV	Location:	N
ADA ID: EAAA0E0230F1	Ramp Type: Perp	Initial Pass/Fail: Fail	Overall Compliance: No	Severity Score: 1.25

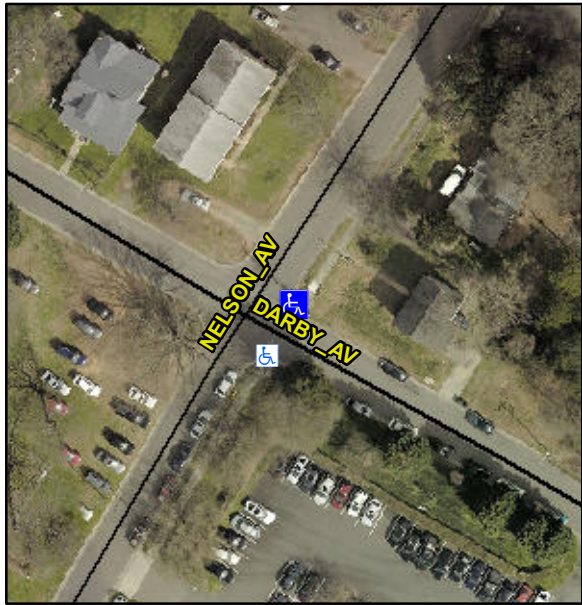
Possible Solutions:		Compliance			Description			Data			
	Remove & Replace Entire Ramp.		N/A	Ramp Length (in)		46.0		Yes	Ramp Slope (%)		6.7	
			Yes	Ramp Width (in)		48.0		No	Ramp XSlope (%)		2.5	
			N/A	Flare Type LT		N/A		N/A	Flare Type RT		N/A	
			N/A	Flare Slope LT (%)		N/A		N/A	Flare Slope RT (%)		N/A	
			N/A	Flare Traversable LT?		N/A		N/A	Flare Traversable RT?		N/A	
			N/A	Landing Length (in)		N/A		N/A	DWS Provided?		N/A	
			N/A	Landing Width (in)		N/A		N/A	DWS Contrast?		N/A	
			N/A	Landing Slope (%)		N/A		N/A	DWS Length (in)		N/A	
			N/A	Landing X Slope (%)		N/A		N/A	DWS Full Width?		N/A	
Surveyor Notes:		N/A			N/A		N/A		DWS Offset (in)		N/A	
PROW/ADA:		Not Found, R304.5.3			N/A		N/A					
					N/A		N/A		Gutter Slope (%)		N/A	
					N/A		N/A		Gutter X Slope (%)		N/A	
					N/A		No		Painted X Walk2?		N/A	
							To SW		X Walk 2 Direction		N/A

N/A		N/A		X Walk 2 Width (in)		N/A	
							3.1		X Walk 2 Slope (%)		N/A	
							9.9		X Walk 2 X Slope (%)		N/A	
					N/A		N/A		Ramp inside XWalk2?		N/A	
							N/A		Clear Space?		N/A	
							N/A		Clear Space to XWalk (in)		N/A	
					N/A		N/A		Storm Grate/Utility Hazard?		N/A	
									Storm Grate/Utility Type			
							N/A				N/A	
									Yes		Surface Condition? (G/P)	
											Good
