Access Compliance Report Public Rights-of-Way (Curb Ramps)

Intersection ID: 12279 Main Street: S_MINT_ST Cross Street: W_MARTIN_LUTHER_KING_JR_BV Location: ADA ID: EB438778655E Ramp Type: Perp Initial Pass/Fail: Fail **Overall Compliance: No Severity Score:** 12.5

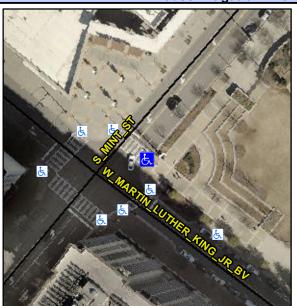
| 1 COSIDIC COIGHOIL | | |
|---|---|--|
| Not Found, R304.2.2 | N/ | |

| Field Measurements/Component Compliance | | | | | | | |
|---|---|---|---|---|---|--|--|
| N/A | Ramp Length (in) | 99.0 | No | Ramp Slope (%) | 8.8 | | |

| 1 COSIDIC COIGHOIL | | |
|---|---|--|
| Remove & Replace Entire Ramp. | | |
