## Access Compliance Report Public Rights-of-Way (Curb Ramps)

Intersection ID: 47581Main Street:ROCK\_ISLAND\_RDCross Street:GLENBURN\_LNLocation:NWADA ID: EB4D34BA78FERamp Type:PerpDiagInitial Pass/Fail:FailOverall Compliance:NoSeverity Score:12.5

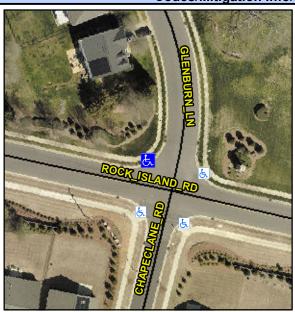
Not Found, R304.2.2

riela measurements/component compnance					
Compliance Description		Data	Compliance Description		Data
N/A	Ramp Length (in)	49.0	No	Ramp Slope (%)	10.6
Yes	Ramp Width (in)	48.0	Yes	Ramp XSlope (%)	0.0
N/A	Flare Type LT	N/A	N/A	Flare Type RT	N/A
N/A	Flare Slope LT (%)	N/A	N/A	Flare Slope RT (%)	N/A
N/A	Flare Traversable LT?	N/A	N/A	Flare Traversable RT?	N/A
N/A	Landing Length (in)	N/A	N/A	DWS Provided?	N/A
N/A	Landing Width (in)	N/A	N/A	DWS Contrast?	N/A
N/A	Landing Slope (%)	N/A	N/A	DWS Length (in)	N/A
N/A	Landing X Slope (%)	N/A	N/A	DWS Full Width?	N/A
N/A	Landing Curb? (Y/N)	N/A	N/A	DWS Offset (in)	N/A
N/A	Shared Landing?	N/A			
N/A	Gutter Ponding?	N/A	N/A	Gutter Slope (%)	N/A
N/A	Gutter Lip Ht (in)	N/A	N/A	Gutter X Slope (%)	N/A
N/A	Painted X Walk1?	No	N/A	Painted X Walk2?	No
	X Walk 1 Direction	To SW		X Walk 2 Direction	To SE
N/A	X Walk 1 Width (in)	N/A	N/A	X Walk 2 Width (in)	N/A
	X Walk 1 Slope (%)	1.5		X Walk 2 Slope (%)	1.0

Remove & Replace Curb Ramp With
Two New Directional Ramps or
Equivalent.
