Access Compliance Report Public Rights-of-Way (Curb Ramps)

Intersection ID: 26923 Main Street: PLAYFAIR_LN Cross Street: SETON_HOUSE_LN Location: S

ADA ID: EB599D949A3E Ramp Type: PerpDiag Initial Pass/Fail: Fail Overall Compliance: No Severity Score: 21.25

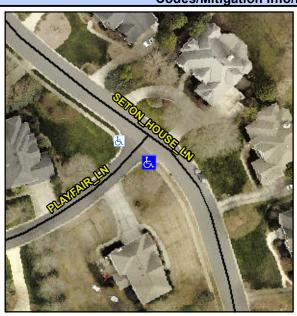
Not Found, R304.5.1, R304.2.2

Field Measurements/Component Compilance					
Compliance Description		Data	Compliance Description		Data
N/A	Ramp Length (in)	95.0	No	Ramp Slope (%)	9.2
No	Ramp Width (in)	38.0	Yes	Ramp XSlope (%)	1.3
N/A	Flare Type LT	N/A	N/A	Flare Type RT	N/A
N/A	Flare Slope LT (%)	N/A	N/A	Flare Slope RT (%)	N/A
N/A	Flare Traversable LT?	N/A	N/A	Flare Traversable RT?	N/A
N/A	Landing Length (in)	N/A	N/A	DWS Provided?	N/A
N/A	Landing Width (in)	N/A	N/A	DWS Contrast?	N/A
N/A	Landing Slope (%)	N/A	N/A	DWS Length (in)	N/A
N/A	Landing X Slope (%)	N/A	N/A	DWS Full Width?	N/A
N/A	Landing Curb? (Y/N)	N/A	N/A	DWS Offset (in)	N/A
N/A	Shared Landing?	N/A			
N/A	Gutter Ponding?	N/A	N/A	Gutter Slope (%)	N/A
N/A	Gutter Lip Ht (in)	N/A	N/A	Gutter X Slope (%)	N/A
N/A	Painted X Walk1?	No	N/A	Painted X Walk2?	No
	X Walk 1 Direction	To NE		X Walk 2 Direction	To NW
N/A	X Walk 1 Width (in)	N/A	N/A	X Walk 2 Width (in)	N/A
	X Walk 1 Slope (%)	2.0		X Walk 2 Slope (%)	3.9

Remove & Replace Curb Ramp With Two New Directional Ramps or Equivalent.
