Access Compliance Report

Public Rights-of-Way

(Curb Ramps)

Intersection ID: 24385	Main Street: BEVERLY_CREST_BV	Cross Street: BECKMORE_PL	Location: SW
ADA ID: EB816BEA2C64	Ramp Type: Perp	Initial Pass/Fail: Pass	Overall Compliance: No
Severity Score: 2.75			
Codes/Mitigation Info/Possible Solution		Field Measurements/Component Compliance

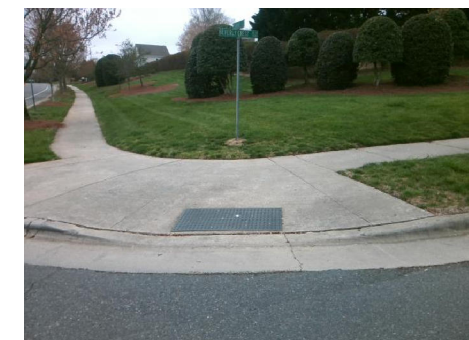
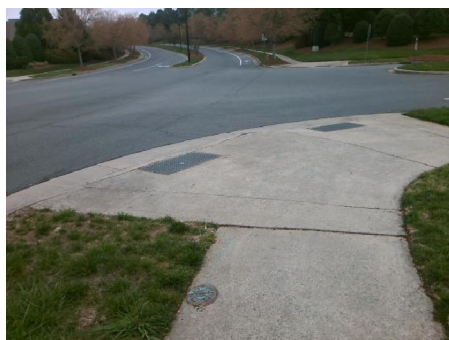
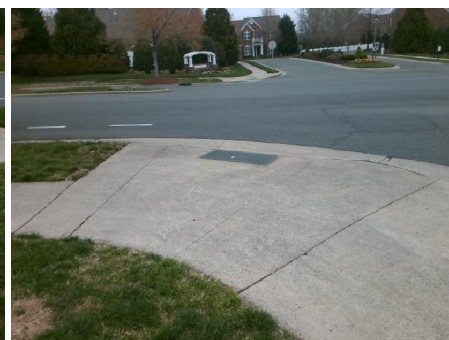
Not Found, R304.5.3, R305.1.4

**Remove & Replace Entire Ramp.
Remove & Replace Gutter.**
