Access Compliance Report

Public Rights-of-Way

(Curb Ramps)

Intersection ID: 49791	Main Street: BAHIA_LN	Cross Street: BARLEY_LN	Location:	W
ADA ID: EB81CC99E35F	Ramp Type: Perp	Initial Pass/Fail: Fail	Overall Compliance: No	Severity Score: 1.25
Codes/Mitigation Info/Possible Solution		Field Measurements/Component Compliance

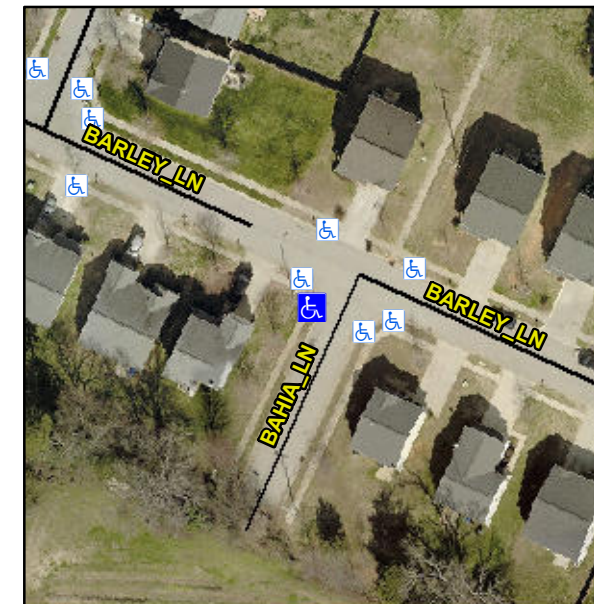
Not Found, R304.5.3

Compliance	Description	Data	Compliance	Description	Data
N/A	Ramp Length (in)	48.0	Yes	Ramp Slope (%)	5.1
Yes	Ramp Width (in)	48.0	No	Ramp XSlope (%)	3.2
N/A	Flare Type LT	N/A	N/A	Flare Type RT	N/A
N/A	Flare Slope LT (%)	N/A	N/A	Flare Slope RT (%)	N/A
N/A	Flare Traversable LT?	N/A	N/A	Flare Traversable RT?	N/A
N/A	Landing Length (in)	N/A	N/A	DWS Provided?	N/A
N/A	Landing Width (in)	N/A	N/A	DWS Contrast?	N/A
N/A	Landing Slope (%)	N/A	N/A	DWS Length (in)	N/A
N/A	Landing X Slope (%)	N/A	N/A	DWS Full Width?	N/A
N/A	Landing Curb? (Y/N)	N/A	N/A	DWS Offset (in)	N/A
N/A	Shared Landing?	N/A			
N/A	Gutter Ponding?	N/A	N/A	Gutter Slope (%)	N/A
N/A	Gutter Lip Ht (in)	0.3	N/A	Gutter X Slope (%)	N/A
N/A	Painted X Walk1?	No	N/A	Painted X Walk2?	N/A
	X Walk 1 Direction	To SE		X Walk 2 Direction	N/A
N/A	X Walk 1 Width (in)	N/A	N/A	X Walk 2 Width (in)	N/A
	X Walk 1 Slope (%)	0.8		X Walk 2 Slope (%)	N/A
	X Walk 1 X Slope (%)	2.2		X Walk 2 X Slope (%)	N/A

Remove & Replace Entire Ramp.
