Access Compliance Report Public Rights-of-Way (Curb Ramps)

Intersection ID: 28338Main Street: CASTLEBAY_DRCross Street: DELBERRY_LNLocation:NEADA ID: EC0F4E48F47BRamp Type: PerpInitial Pass/Fail: FailOverall Compliance: NoSeverity Score: 12.5

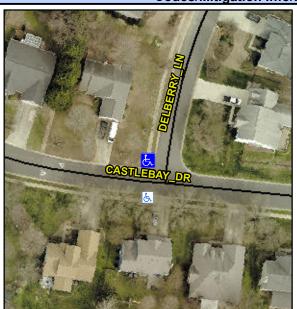
Compli	iance Description	Data	Comp	liance Description	Data
N/A	Ramp Length (in)	50.0	Yes	Ramp Slope (%)	6.3
Yes	Ramp Width (in)	48.0	No	Ramp XSlope (%)	6.1
N/A	Flare Type LT	N/A	N/A	Flare Type RT	N/A
N/A	Flare Slope LT (%)	N/A	N/A	Flare Slope RT (%)	N/A
N/A	Flare Traversable LT?	N/A	N/A	Flare Traversable RT?	N/A
N/A	Landing Length (in)	N/A	N/A	DWS Provided?	N/A
N/A	Landing Width (in)	N/A	N/A	DWS Contrast?	N/A
N/A	Landing Slope (%)	N/A	N/A	DWS Length (in)	N/A
N/A	Landing X Slope (%)	N/A	N/A	DWS Full Width?	N/A
N/A	Landing Curb? (Y/N)	N/A	N/A	DWS Offset (in)	N/A
N/A	Shared Landing?	N/A			
N/A	Gutter Ponding?	N/A	N/A	Gutter Slope (%)	N/A
N/A	Gutter Lip Ht (in)	N/A	N/A	Gutter X Slope (%)	N/A
N/A	Painted X Walk1?	No	N/A	Painted X Walk2?	N/A
	X Walk 1 Direction	To SW		X Walk 2 Direction	N/A
N/A	X Walk 1 Width (in)	N/A	N/A	X Walk 2 Width (in)	N/A
	X Walk 1 Slope (%)	3.9		X Walk 2 Slope (%)	N/A
	X Walk 1 X Slope (%)	1.1		X Walk 2 X Slope (%)	N/A

N/A	Ramp inside XWalk1?	N/A	N/A	Ramp inside XWalk2?	N/A
	Road Slope (%)	4.7	N/A	Clear Space?	N/A
	Road X Slope (%)	4.2	N/A	Clear Space to XWalk (in)	N/A
N/A	Any Obstructions?	N/A	N/A	Storm Grate/Utility Hazard?	N/A
	Obstruction Type		l	Storm Grate/Utility Type	
		N/A			N/A
			Yes	Surface Condition? (G/P)	Good

Possible Solutions:	Con
Remove & Replace Entire Ramp.	N/A
·	Yes
	N/A
	N/A
	N/A
	N/A
Surveyor Notes:	N/A
N/A	N/A
	N/A
	N/A
	N/A
PROW/ADA:	N/A
Not Found, R304.5.3	N/A
	N/A
	N/A
	N/A
