Access Compliance Report

Public Rights-of-Way (Curb Ramps)

Intersection ID: 9461	Main Street: BANCROFT_ST	Cross Street: W_28TH_ST	Location:	N
ADA ID: EC108A652EEB	Ramp Type: Combination2	Initial Pass/Fail: Fail	Overall Compliance: No	Severity Score: 1.25
Codes/Mitigation Info/Possible Solution		Field Measurements/Component Compliance

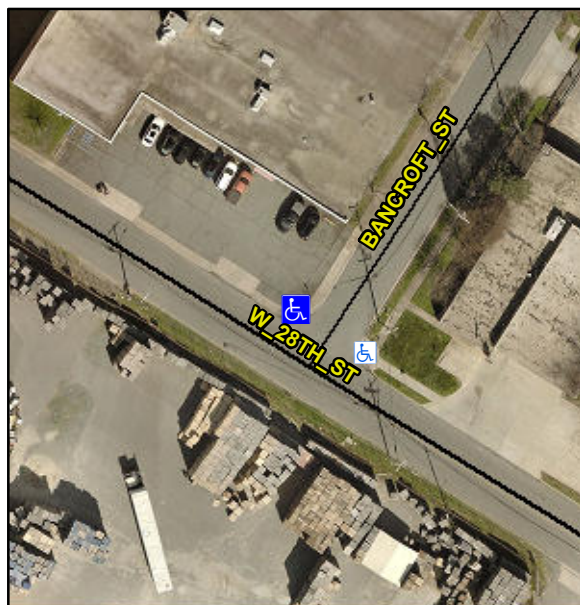
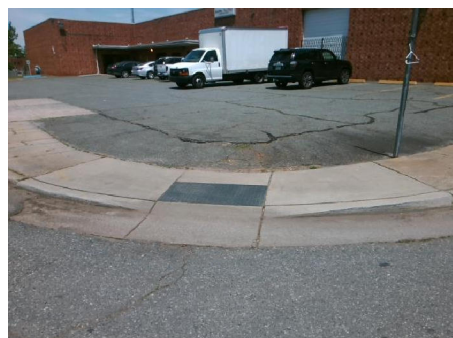
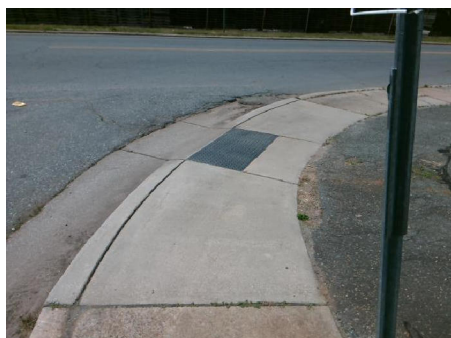
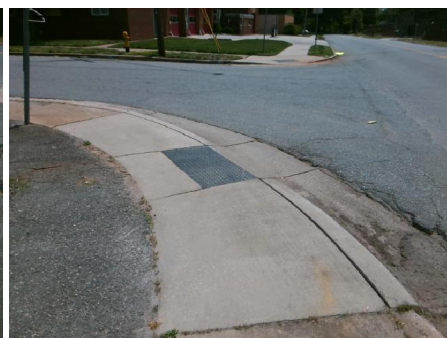
LT RP < 5%

Not Found, R304.5.3

Remove & Replace Entire Ramp.
