Access Compliance Report Public Rights-of-Way (Curb Ramps)

Intersection ID: 13255Main Street: CENTRAL_AVCross Street: IRIS_DRLocation:SWADA ID: EC587DD227D7Ramp Type: ParaInitial Pass/Fail: FailOverall Compliance: NoSeverity Score: 13.75

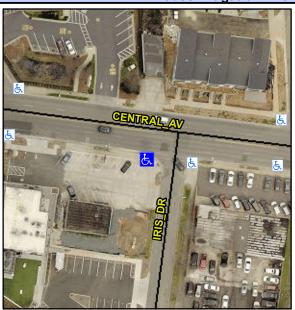
1 Ossible Solution	
Possible Solutions:	Com
Remove & Replace Entire Ramp.	N/A
•	Yes
	No
	No
	N/A
	N/A
Surveyor Notes:	N/A
DAMAGED RT FL	N/A
	N/A
	N/A
	N/A
PROW/ADA:	N/A
R304.3.2, R304.5.3	N/A
	N/A
	N/A

Field Measurements/Component Compliance							
Compl	iance Description	Data	Compl	iance Description	Data		
N/A	Ramp Length LT (in)	37.0	N/A	Ramp Length RT (in)	34.0		
Yes	Ramp Width LT (in)	85.5	Yes	Ramp Width RT (in)	76.5		
No	Ramp Slope LT (%)	8.7	Yes	Ramp Slope RT (%)	5.7		
No	Ramp XSlope LT (%)	2.8	No	Ramp XSlope RT (%)	4.2		
N/A	Landing Length (in)	N/A	N/A	DWS Provided?	N/A		
N/A	Landing Width (in)	N/A	N/A	DWS Contrast?	N/A		
N/A	Landing Slope (%)	N/A	N/A	DWS Length (in)	N/A		
N/A	Landing X Slope (%)	N/A	N/A	DWS Full Width?	N/A		
N/A	Landing Curb? (Y/N)	N/A	N/A	DWS Offset (in)	N/A		
N/A	Shared Landing?	N/A					
N/A	Gutter Ponding?	N/A	N/A	Gutter Slope (%)	N/A		
N/A	Gutter Lip Ht (in)	N/A	N/A	Gutter X Slope (%)	N/A		
N/A	Painted X Walk1?	No	N/A	Painted X Walk2?	N/A		
	X Walk 1 Direction	То Е		X Walk 2 Direction	N/A		
N/A	X Walk 1 Width (in)	N/A	N/A	X Walk 2 Width (in)	N/A		
	X Walk 1 Slope (%)	2.6		X Walk 2 Slope (%)	N/A
