Access Compliance Report Public Rights-of-Way (Curb Ramps)

Main Street: KENSAL_GREEN_DR Intersection ID: N/A **Cross Street: ORKNEY_CT** Location: SW **Overall Compliance: No** ADA ID: EC867B80C978 Ramp Type: Directional1 Initial Pass/Fail: Fail **Severity Score:** 10

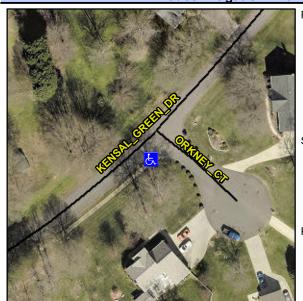
Field Measurements/Component Compliance									
Comp	liance Description	Data	Comp	liance Description	Data				
N/A	Ramp Length (in)	46.0	N/A	Grade Break?	N/A				
No	Ramp Width (in)	47.5	N/A	Grade Break Slope (%)	0.0				
Yes	Ramp Slope (%)	1.1	N/A	Grade Break XSlope (%)	0.0				
No	Ramp XSlope (%)	2.4							
N/A	Flare Type LT	N/A	N/A	Flare Type RT	N/A				
N/A	Flare Slope LT (%)	N/A	N/A	Flare Slope RT (%)	0.0				
N/A	Flare Traversable LT?	N/A	N/A	Flare Traversable RT?	N/A				
N/A	Landing Length (in)	0.0	N/A	DWS Provided?	N/A				
N/A	Landing Width (in)	0.0	N/A	DWS Contrast?	N/A				
N/A	Landing Slope (%)	0.0	N/A	DWS Length (in)	N/A				
N/A	Landing X Slope (%)	0.0	N/A	DWS Full Width?	N/A				
N/A	Landing Curb? (Y/N)	N/A	N/A	DWS Offset LT (in)	N/A				
N/A	Shared Landing?	N/A	N/A	DWS Offset RT (in)	N/A				
N/A	Gutter Ponding?	0.0	N/A	Gutter Slope (%)	N/A				
N/A	Gutter Lip Ht (in)	0.0	N/A	Gutter X Slope (%)	N/A

N/A	Painted X Walk1?	No		Road Slope (%)	0.7				
	X Walk 1 Direction	To NE		Road X Slope (%)	1.9				
	X Walk 1 Width (in)	N/A		Clear Space?	N/A				
	X Walk 1 Slope (%)	0.7	N/A	Clear Space to XWalk (in)	N/A				
	X Walk 1 X Slope (%)	1.9	N/A	Storm Grate/Utility Hazard?	N/A				
N/A	Ramp inside XWalk1?	N/A		Storm Grate/Utility Type					
N/A	Any Obstructions?	N/A			N/A				
	Obstruction Type		Yes	Surface Condition? (G/P)	Good				
		N/A	N/A	Curb Slope (%)	5.3

Possible Solutions: Remove & Replace Entire Ramp.	No Yes
Remove & Replace Entire Ramp.	No Ye: No
·	Ye: No
	No
	NI//
	N/A
	N/A
surveyor Notes:	N/A
N/A	N/A
	N/A
	N/A
	N/A
ROW/ADA:	N/A
R304.5.1, R304.5.3	N/A
,	N/A
	N/A
	N/A

N/
		N/
PROW/ADA:		N/
R304.5.1, R304.5.3		N/
,		N/
		N/
		N/
		N/
		N/
Total Cost:	\$ 1600.00
