Access Compliance Report

Public Rights-of-Way

(Curb Ramps)

Intersection ID: 11256	Main Street: N_IRWIN_AV	Cross Street: W_5TH_ST	Location: N
ADA ID: ECB11A116BA2	Ramp Type: Perp	Initial Pass/Fail: Fail	Overall Compliance: No
Severity Score: 33.75			
Codes/Mitigation Info/Possible Solution		Field Measurements/Component Compliance

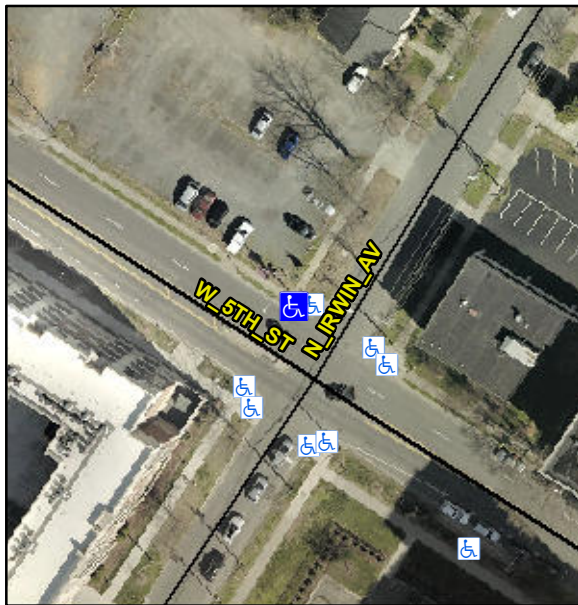
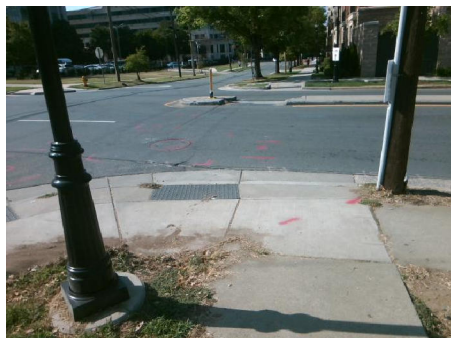
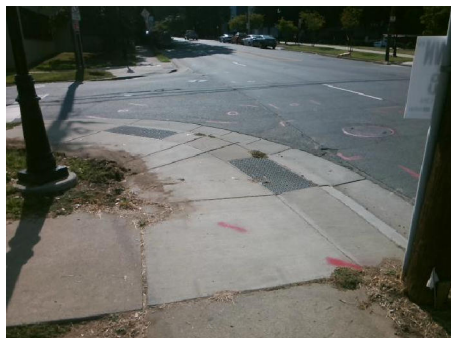
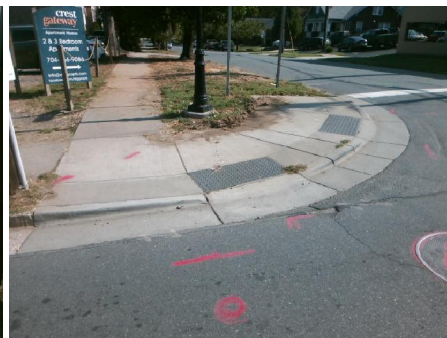
Not Found, R304.5.1, R304.5.3

Compliance	Description	Data	Compliance	Description	Data
N/A	Ramp Length (in)	84.0	Yes	Ramp Slope (%)	6.7
No	Ramp Width (in)	36.0	No	Ramp XSlope (%)	7.7
N/A	Flare Type LT	N/A	N/A	Flare Type RT	N/A
N/A	Flare Slope LT (%)	N/A	N/A	Flare Slope RT (%)	N/A
N/A	Flare Traversable LT?	N/A	N/A	Flare Traversable RT?	N/A
N/A	Landing Length (in)	N/A	N/A	DWS Provided?	N/A
N/A	Landing Width (in)	N/A	N/A	DWS Contrast?	N/A
N/A	Landing Slope (%)	N/A	N/A	DWS Length (in)	N/A
N/A	Landing X Slope (%)	N/A	N/A	DWS Full Width?	N/A
N/A	Landing Curb? (Y/N)	N/A	N/A	DWS Offset (in)	N/A
N/A	Shared Landing?	N/A			
N/A	Gutter Ponding?	N/A	N/A	Gutter Slope (%)	N/A
N/A	Gutter Lip Ht (in)	N/A	N/A	Gutter X Slope (%)	N/A
N/A	Painted X Walk1?	No	N/A	Painted X Walk2?	N/A
	X Walk 1 Direction	To SW		X Walk 2 Direction	N/A
N/A	X Walk 1 Width (in)	N/A	N/A	X Walk 2 Width (in)	N/A
	X Walk 1 Slope (%)	5.2		X Walk 2 Slope (%)	N/A
	X Walk 1 X Slope (%)	4.9		X Walk 2 X Slope (%)	N/A

Remove & Replace Entire Ramp.
