Access Compliance Report Public Rights-of-Way (Curb Ramps)

Intersection ID: 13795 Main Street: DENBUR_DR Cross Street: LUSTERLEAF_HOLLY_RD Location: Ε Severity Score: **ADA ID: ED2B5E0F5267** Ramp Type: Perp Initial Pass/Fail: Pass **Overall Compliance: No** 0.25

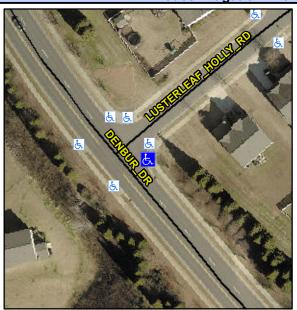
Field Measurements/Component Compliance							
Comp	liance Description	Data	Comp	liance Description	Data		
N/A	Ramp Length (in)	47.5	Yes	Ramp Slope (%)	5.5		
Yes	Ramp Width (in)	48.0	Yes	Ramp XSlope (%)	2.6		
N/A	Flare Type LT	Sloped	N/A	Flare Type RT	N/A		
N/A	Flare Slope LT (%)	3.2	N/A	Flare Slope RT (%)	7.8		
N/A	Flare Traversable LT?	No	N/A	Flare Traversable RT?	No		
Yes	Landing Length (in)	60.0	Yes	DWS Provided?	Yes		
Yes	Landing Width (in)	48.0	Yes	DWS Contrast?	Yes		
No	Landing Slope (%)	4.8	Yes	DWS Length (in)	24.0		
No	Landing X Slope (%)	3.5	Yes	DWS Full Width?	Yes		
N/A	Landing Curb? (Y/N)	No	Yes	DWS Offset (in)	1.5		
N/A	Shared Landing?	Yes					
Yes	Gutter Ponding?	No	Yes	Gutter Slope (%)	3.6		
Yes	Gutter Lip Ht (in)	0.0	Yes	Gutter X Slope (%)	2.7		
N/A	Painted X Walk1?	No	N/A	Painted X Walk2?	N/A		
	X Walk 1 Direction	To SW		X Walk 2 Direction	N/A		
N/A	X Walk 1 Width (in)	N/A	N/A	X Walk 2 Width (in)	N/A

X Walk 1 Slope (%)	0.9		X Walk 2 Slope (%)	N/A		
	X Walk 1 X Slope (%)	3.9		X Walk 2 X Slope (%)	N/A		
N/A	Ramp inside XWalk1?	N/A	N/A	Ramp inside XWalk2?	N/A		
	Road Slope (%)	N/A	N/A	Clear Space?	Yes		
	Road X Slope (%)	N/A	N/A	Clear Space to XWalk (in)	N/A		
Yes	Any Obstructions?	No	Yes	Storm Grate/Utility Hazard?	No		
	Obstruction Type			Storm Grate/Utility Type			
		N/A			N/A		
			Yes	Surface Condition? (G/P)	Good		
22 A

Possible Solutions:				
Remove & Replace Entire Ramp.				
Surveyor Notes:				
N/A				
N/A				
PROW/ADA:				
Not Found, R304.2.2-Perp, R304.3.2- Para, R304.5.3				
1 414, 1100 11010
