Access Compliance Report

Public Rights-of-Way

(Curb Ramps)

| Intersection ID: 10868 | Main Street: N_TRYON_ST | Cross Street: DALTON_AV | Location: SW |

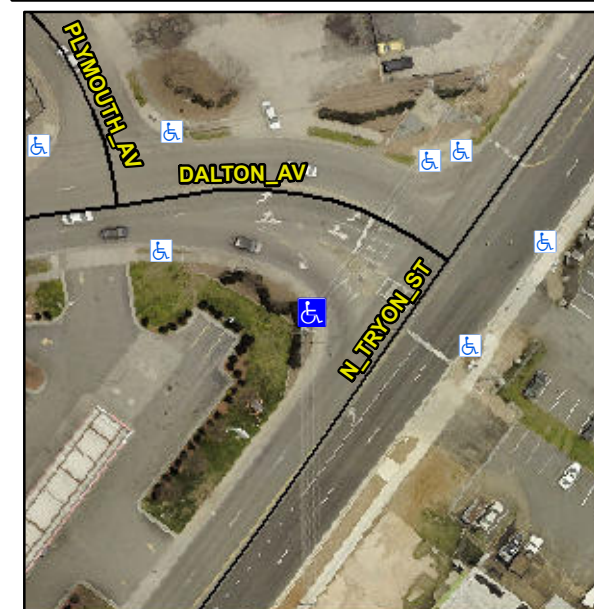
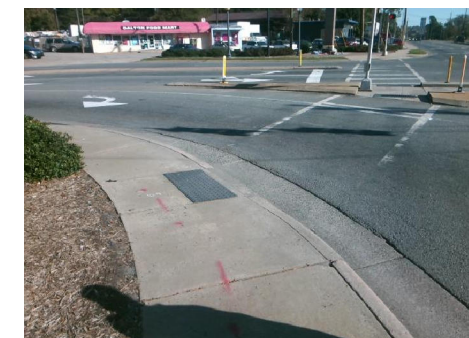
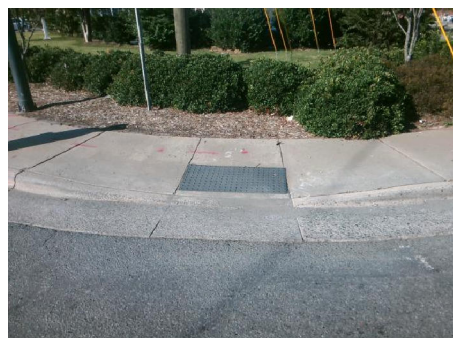
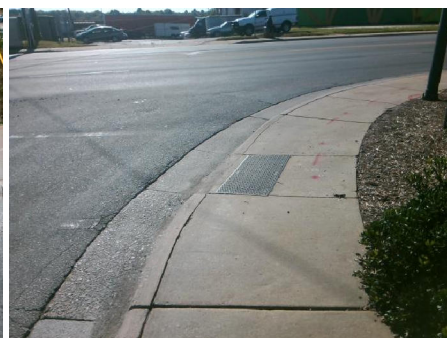
| ADA ID: ED53E20A1F19 | Ramp Type: Perp | Initial Pass/Fail: Fail | Overall Compliance: No |
| Severity Score: 21.25 | | | |

R304.5.1, R304.2.2

| Compliance | Description | Data | Compliance | Description | Data |
|---|---|---|---|---|---|
| N/A | Ramp Length (in) | 62.0 | No | Ramp Slope (%) | 10.9 |
| No | Ramp Width (in) | 44.5 | Yes | Ramp XSlope (%) | 1.5 |

Remove & Replace Entire Ramp.
