# Access Compliance Report

## Public Rights-of-Way

| Intersection ID: 31503 | Main Street: CHARIDGE_LN | Cross Street: STONEY_PLACE_CT | Location: SW |
| ADA ID: ED97D774AA04 | Ramp Type: PerpDiag | Initial Pass/Fail: Fail | Overall Compliance: No |

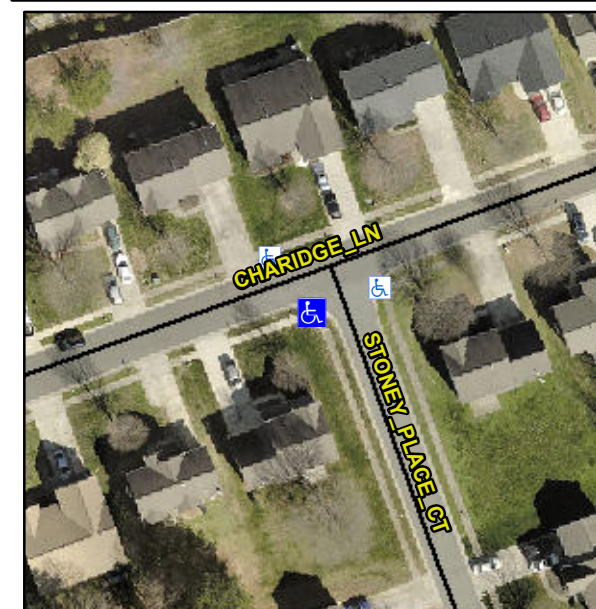
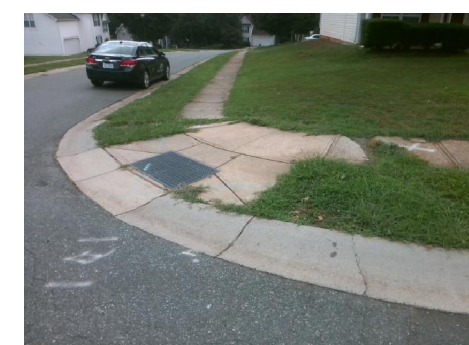
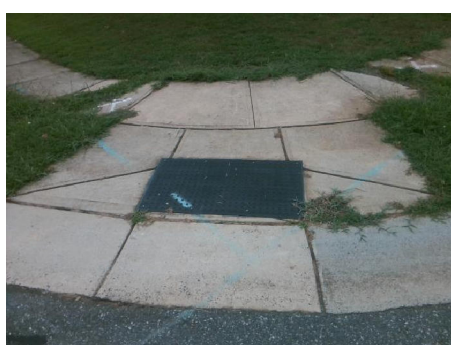
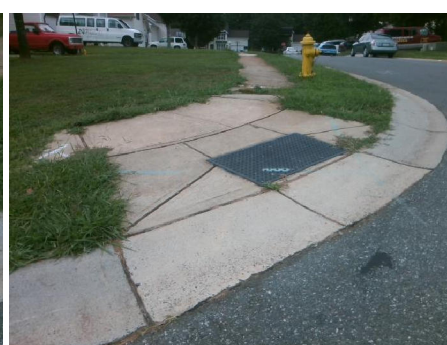
**Not Found, R304.5.1, R304.2.2, R304.5.3**

| Compliance | Description | Data | Compliance | Description | Data |
|---|---|---|---|---|---|
| N/A | Ramp Length (in) | 46.0 | No | Ramp Slope (%) | 10.5 |
| No | Ramp Width (in) | 33.5 | No | Ramp XSlope (%) | 8.8 |

**Remove & Replace Curb Ramp With Two New Directional Ramps or Equivalent.**
