Access Compliance Report Public Rights-of-Way (Curb Ramps)

Intersection ID: 3313 Main Street: PROSPERITY CHURCH RD **Cross Street: OLD TIMBER RD** Location: SW

Overall Compliance: No Severity Score: 58.75 **ADA ID: EDBF84012569** Ramp Type: Combination1 Initial Pass/Fail: Fail

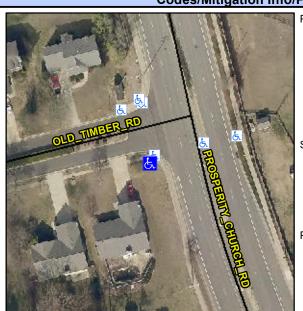
Street 1 Name StopSign Stop Condition-Street 1 OLD TIMBER RD N/A Street 2 Name Stop Condition-Street 2 N/A Possible Solutions: Compliance Description N/A Remove & Replace Entire Ramp. Yes No No N/A No Surveyor Notes: N/A N/A N/A N/A N/A N/A PROW/ADA: N/A R304.5.1, R304.5.3, R304.3.2 N/A N/A N/A N/A N/A N/A
