Access Compliance Report

Public Rights-of-Way

(Curb Ramps)

Intersection ID: 13045	Main Street: HAMORTON_PL	Cross Street: NANDINA_ST	Location: NE
ADA ID: EDDD162FAC27	Ramp Type: BlendTrans2	Initial Pass/Fail: Fail	Overall Compliance: No
Severity Score: 1.25			
Codes/Mitigation Info/Possible Solution		Field Measurements/Component Compliance

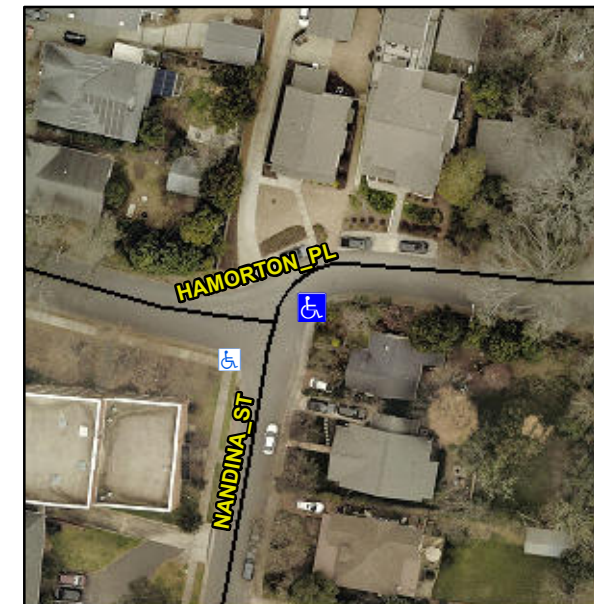
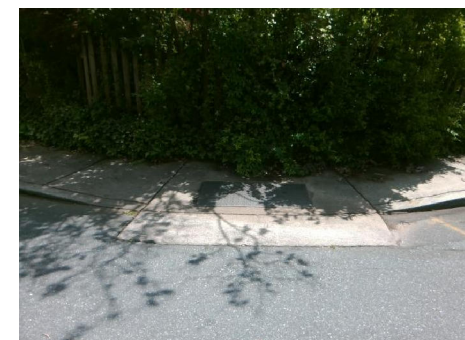
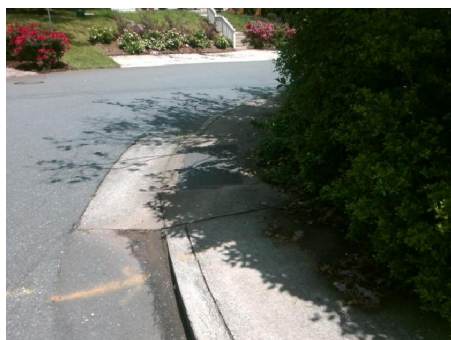
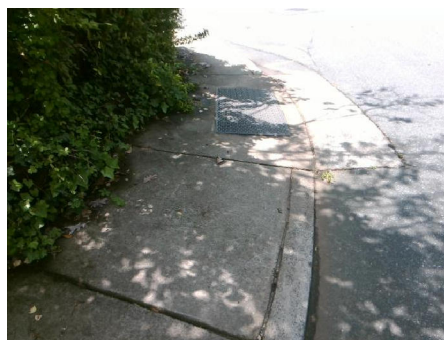
VEGETATION OVERGROWTH

R304.5.3

Remove & Replace Curb Ramp With Two New Directional Ramps or Equivalent.
