Access Compliance Report

Public Rights-of-Way

(Curb Ramps)

Intersection ID: 25287	Main Street: CEDAR_POINT_LN	Cross Street: JOHNSTON_RD	Location: SE
ADA ID: EDE73C1E6022	Ramp Type: PerpDiag	Initial Pass/Fail: Fail	Overall Compliance: No
Severity Score: 12.5			
Codes/Mitigation Info/Possible Solution		Field Measurements/Component Compliance

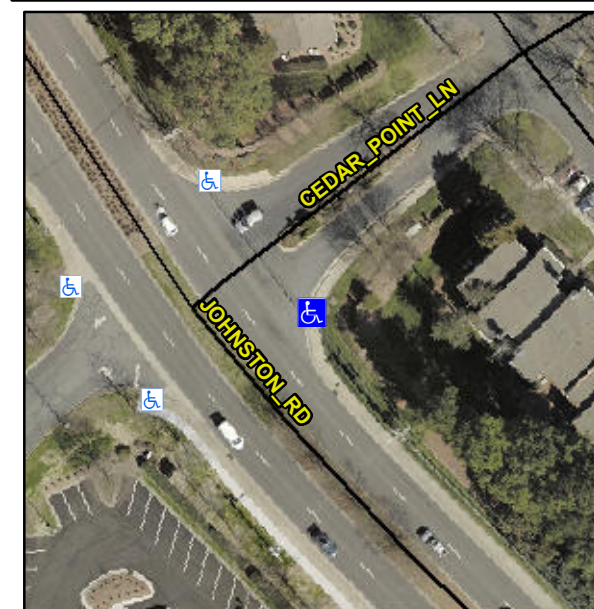
Not Found, R304.2.2

Compliance	Description	Data	Compliance	Description	Data
N/A	Ramp Length (in)	60.0	No	Ramp Slope (%)	8.4
Yes	Ramp Width (in)	48.0	Yes	Ramp XSlope (%)	1.7
N/A	Flare Type LT	N/A	N/A	Flare Type RT	N/A
N/A	Flare Slope LT (%)	N/A	N/A	Flare Slope RT (%)	N/A
N/A	Flare Traversable LT?	N/A	N/A	Flare Traversable RT?	N/A
N/A	Landing Length (in)	N/A	N/A	DWS Provided?	N/A
N/A	Landing Width (in)	N/A	N/A	DWS Contrast?	N/A
N/A	Landing Slope (%)	N/A	N/A	DWS Length (in)	N/A
N/A	Landing X Slope (%)	N/A	N/A	DWS Full Width?	N/A
N/A	Landing Curb? (Y/N)	N/A	N/A	DWS Offset (in)	N/A
N/A	Shared Landing?	N/A			
N/A	Gutter Ponding?	N/A	N/A	Gutter Slope (%)	N/A
N/A	Gutter Lip Ht (in)	N/A	N/A	Gutter X Slope (%)	N/A
N/A	Painted X Walk1?	No	N/A	Painted X Walk2?	No
	X Walk 1 Direction	To NW		X Walk 2 Direction	To SW
N/A	X Walk 1 Width (in)	N/A	N/A	X Walk 2 Width (in)	N/A
	X Walk 1 Slope (%)	3.8		X Walk 2 Slope (%)	7.7
	X Walk 1 X Slope (%)	6.3		X Walk 2 X Slope (%)	0.2

N/A	Ramp inside XWalk1?	N/A	N/A	Ramp inside XWalk2?	N/A
	Road Slope (%)	1.4	N/A	Clear Space?	N/A
	Road X Slope (%)	6.9	N/A	Clear Space to XWalk (in)	N/A
N/A	Any Obstructions?	N/A	N/A	Storm Grate/Utility Hazard?	N/A
	Obstruction Type			Storm Grate/Utility Type	
		N/A			N/A
		Yes		Surface Condition? (G/P)	Good

Remove & Replace Curb Ramp With Two New Directional Ramps or Equivalent.
