# Access Compliance Report

## Public Rights-of-Way

| Intersection ID: 31714 | Main Street: BLUE_ASH_LN | Cross Street: DEODORA_CEDAR_LN | Location: NW |
| ADA ID: EE14396D94B7 | Ramp Type: PerpDiag | Initial Pass/Fail: Fail | Overall Compliance: No |

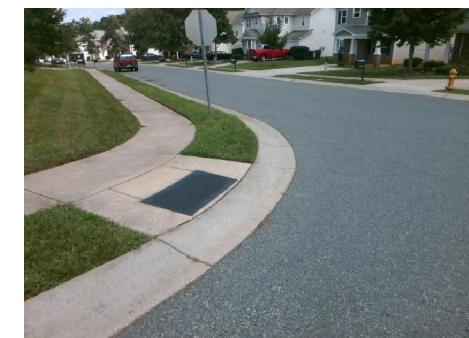
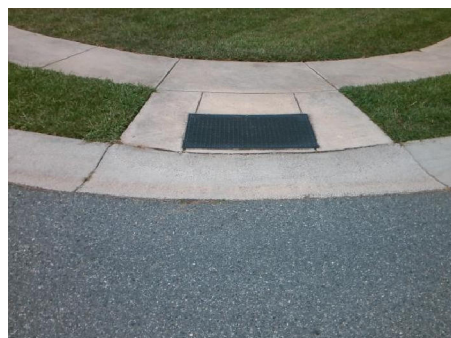
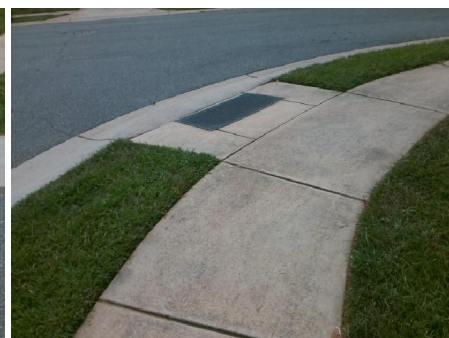
**Not Found, R304.5.1, R304.2.2, R304.5.3**

| Compliance | Description | Data | Compliance | Description | Data |
|---|---|---|---|---|---|
| N/A | Ramp Length (in) | 48.0 | No | Ramp Slope (%) | 9.2 |
| No | Ramp Width (in) | 40.5 | No | Ramp XSlope (%) | 4.5 |

**Remove & Replace Curb Ramp With Two New Directional Ramps or Equivalent.**
