# Access Compliance Report

## Public Rights-of-Way

### (Curb Ramps)

| Intersection ID: 14530 | Main Street: E_5TH_ST | Cross Street: N_LAUREL_AV | Location: NE |

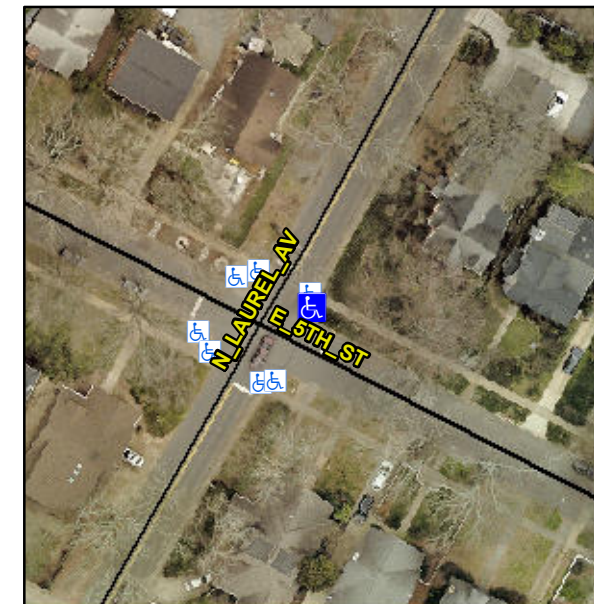
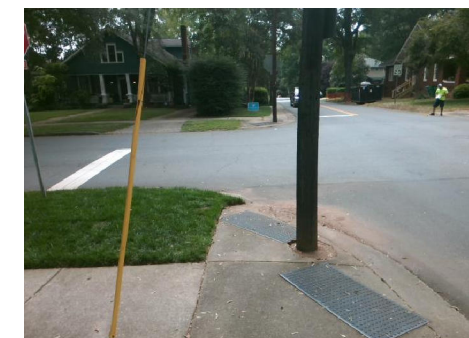
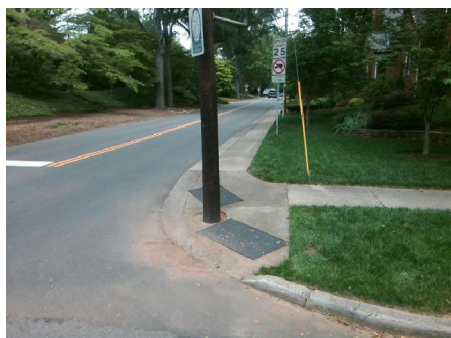
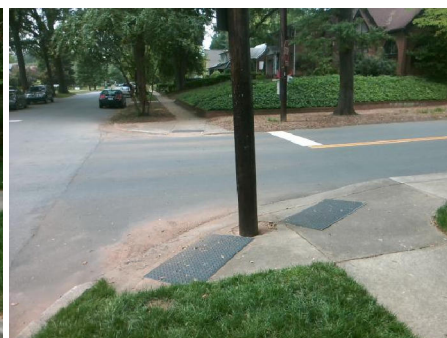
| ADA ID: EE5BA33D14D3 | Ramp Type: Perp | Initial Pass/Fail: Fail | Overall Compliance: No |
| Severity Score: 12.5 | | | |

**R304.2.2**

| Compliance | Description | Data | Compliance | Description | Data |
|---|---|---|---|---|---|
| N/A | Ramp Length (in) | 24.0 | No | Ramp Slope (%) | 10.0 |

**Remove & Replace Entire Ramp.**
