Access Compliance Report

Public Rights-of-Way

(Curb Ramps)

Intersection ID: 28502	Main Street: BROOK_FARM_LN	Cross Street: NORTHWOODS_FOREST_DR	Location: SE
ADA ID: EE872084EE45	Ramp Type: Combination1	Initial Pass/Fail: Fail	Overall Compliance: No
Severity Score: 36.25			
Codes/Mitigation Info/Possible Solution		Field Measurements/Component Compliance

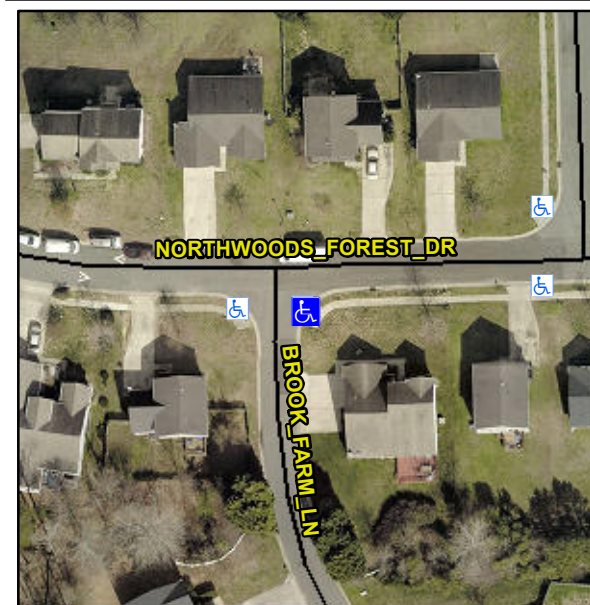
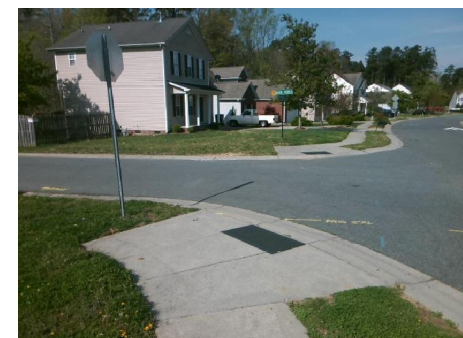
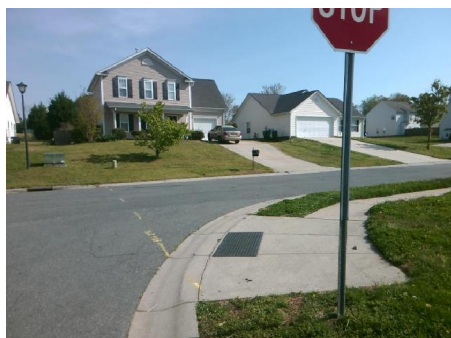
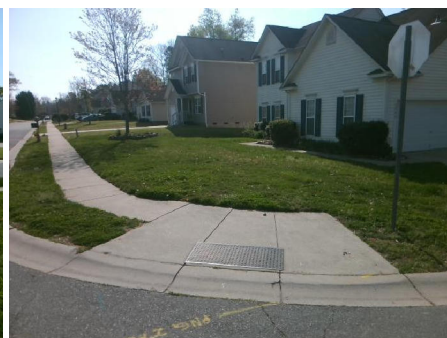
RP & RT RP < 5%

Not Found, R304.5.1, R304.5.3

Compliance	Description	Data	Compliance	Description	Data
N/A	Ramp Length LT (in)	34.5	N/A	Ramp Length RT (in)	39.0
Yes	Ramp Width LT (in)	48.0	Yes	Ramp Width RT (in)	96.0
Yes	Ramp Slope LT (%)	6.5	Yes	Ramp Slope RT (%)	3.8
No	Ramp XSlope LT (%)	4.7	No	Ramp XSlope RT (%)	2.8
N/A	Ramp Length (in)	96.0	Yes	Ramp Slope (%)	4.2
No	Ramp Width (in)	30.5	No	Ramp XSlope (%)	3.8
N/A	Flare Type LT	N/A	N/A	Flare Type RT	N/A
N/A	Flare Slope LT (%)	N/A	N/A	Flare Slope RT (%)	N/A
N/A	Flare Traversable LT?	N/A	N/A	Flare Traversable RT?	N/A
N/A	Landing Length (in)	N/A	N/A	DWS Provided?	N/A
N/A	Landing Width (in)	N/A	N/A	DWS Contrast?	N/A
N/A	Landing Slope (%)	N/A	N/A	DWS Length (in)	N/A
N/A	Landing X Slope (%)	N/A	N/A	DWS Full Width?	N/A
N/A	Landing Curb? (Y/N)	N/A	N/A	DWS Offset (in)	N/A
N/A	Shared Landing?	N/A			
N/A	Gutter Ponding?	N/A	N/A	Gutter Slope (%)	N/A
N/A	Gutter Lip Ht (in)	N/A	N/A	Gutter X Slope (%)	N/A
N/A	Painted X Walk1?	No	N/A	Painted X Walk2?	N/A

Remove & Replace Entire Ramp.
