# Access Compliance Report

## Public Rights-of-Way

### (Curb Ramps)

Intersection ID: 14237	Main Street: BASCOM_ST	Cross Street: LABURNUM_AV	Location:	W
ADA ID: EF0ECE583084	Ramp Type: Perp	Initial Pass/Fail: Fail	Overall Compliance: No	Severity Score: 1.25

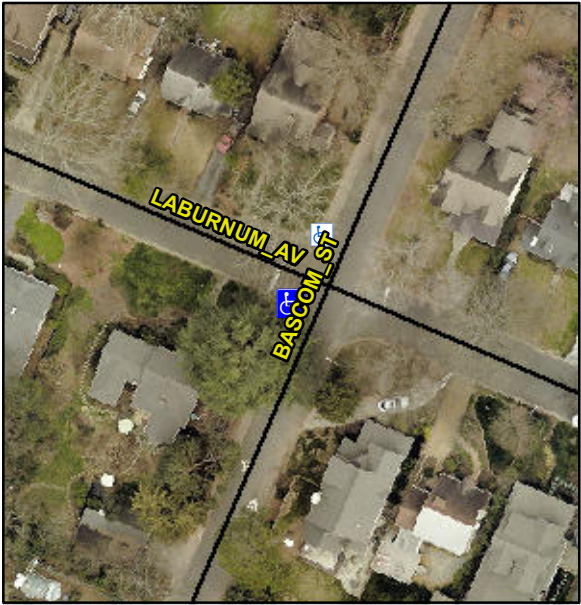
Possible Solutions:		<b>Compliance</b>	<b>Description</b>	<b>Data</b>
	<b>Remove &amp; Replace Entire Ramp.</b>		<b>Yes</b>	Ramp Length (in)	60.0
			<b>No</b>	Ramp Width (in)	50.0
			<b>N/A</b>	Flare Type LT	N/A
			<b>N/A</b>	Flare Slope LT (%)	N/A
			<b>N/A</b>	Flare Traversable LT?	N/A
			<b>N/A</b>	Landing Length (in)	N/A
			<b>N/A</b>	Landing Width (in)	N/A
			<b>N/A</b>	Landing Slope (%)	N/A
			<b>N/A</b>	Landing X Slope (%)	N/A
<p>Surveyor Notes:</p> <p><b>N/A</b></p> <p>PROW/ADA:</p> <p><b>Not Found, R304.5.3</b></p>			<b>N/A</b>	Flare Type RT	N/A
			<b>N/A</b>	Flare Slope RT (%)	N/A
			<b>N/A</b>	Flare Traversable RT?	N/A
			<b>N/A</b>	DWS Provided?	N/A
			<b>N/A</b>	DWS Contrast?	N/A
			<b>N/A</b>	DWS Length (in)	N/A
			<b>N/A</b>	DWS Full Width?	N/A
			<b>N/A</b>	DWS Offset (in)	N/A
			<b>N/A</b>	Shared Landing?	N/A

<b>N/A</b>	Gutter Ponding?	N/A
			<b>N/A</b>	Gutter Lip Ht (in)	0.5
			<b>No</b>	Painted X Walk1?	N/A
				X Walk 1 Direction	To NE
			<b>N/A</b>	X Walk 1 Width (in)	N/A
				X Walk 1 Slope (%)	2.3
				X Walk 1 X Slope (%)	3.0
			<b>N/A</b>	Ramp inside XWalk1?	N/A
			<b>N/A</b>	Road Slope (%)	N/A
			<b>N/A</b>	Road X Slope (%)	N/A
			<b>N/A</b>	Any Obstructions?	N/A
				Obstruction Type	
			<b>N/A</b>		
			<b>N/A</b>		
			<b>Yes</b>	Surface Condition? (G/P)	Good
