Access Compliance Report Public Rights-of-Way (Curb Ramps)

Intersection ID: 12201 Main Street: HIGHLAND_AV Cross Street: MARKET_ST Location: E

ADA ID: EF67B3136DDD Ramp Type: Perp Initial Pass/Fail: Fail Overall Compliance: No Severity Score: 35

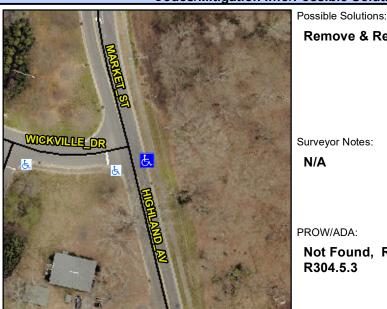
Compliance Description Date Compliance Description									
	liance Description	Data		liance Description	Data				
N/A	Ramp Length (in)	60.5	No	Ramp Slope (%)	13.3				
No	Ramp Width (in)	47.0	No	Ramp XSlope (%)	4.9				
N/A	Flare Type LT	N/A	N/A	Flare Type RT	N/A				
N/A	Flare Slope LT (%)	N/A	N/A	Flare Slope RT (%)	N/A				
N/A	Flare Traversable LT?	N/A	N/A	Flare Traversable RT?	N/A				
N/A	Landing Length (in)	N/A	N/A	DWS Provided?	N/A				
N/A	Landing Width (in)	N/A	N/A	DWS Contrast?	N/A				
N/A	Landing Slope (%)	N/A	N/A	DWS Length (in)	N/A				
N/A	Landing X Slope (%)	N/A	N/A	DWS Full Width?	N/A				
N/A	Landing Curb? (Y/N)	N/A	N/A	DWS Offset (in)	N/A				
N/A	Shared Landing?	N/A							
N/A	Gutter Ponding?	N/A	N/A	Gutter Slope (%)	N/A				
N/A	Gutter Lip Ht (in)	N/A	N/A	Gutter X Slope (%)	N/A				
N/A	Painted X Walk1?	No	N/A	Painted X Walk2?	N/A				
	X Walk 1 Direction	To W		X Walk 2 Direction	N/A				
N/A	X Walk 1 Width (in)	N/A	N/A	X Walk 2 Width (in)	N/A

X Walk 1 Slope (%)	1.8		X Walk 2 Slope (%)	N/A				
	X Walk 1 X Slope (%)	3.8		X Walk 2 X Slope (%)	N/A				
N/A	Ramp inside XWalk1?	N/A	N/A	Ramp inside XWalk2?	N/A				
	Road Slope (%)	N/A	N/A	Clear Space?	N/A				
	Road X Slope (%)	N/A	N/A	Clear Space to XWalk (in)	N/A				
N/A	Any Obstructions?	N/A	N/A	Storm Grate/Utility Hazard?	N/A				
	Obstruction Type			Storm Grate/Utility Type					
		N/A			N/A				
			Yes	Surface Condition? (G/P)	Good				
100

Remove & Replace Entire Ramp.								
Surveyor Notes:								
•								
N/A								
PROW/ADA:								
Not Found, R304.5.1, R304.2.2,								
R304.5.3
