Access Compliance Report

Public Rights-of-Way

(Curb Ramps)

Intersection ID: 28104	Main Street: CRUDEN_BAY_WY	Cross Street: DELMAHOY_DR	Location: SE
ADA ID: EF8CC219BBFE	Ramp Type: Perp	Initial Pass/Fail: Fail	Overall Compliance: No
Severity Score: 21.25			
Codes/Mitigation Info/Possible Solution		Field Measurements/Component Compliance

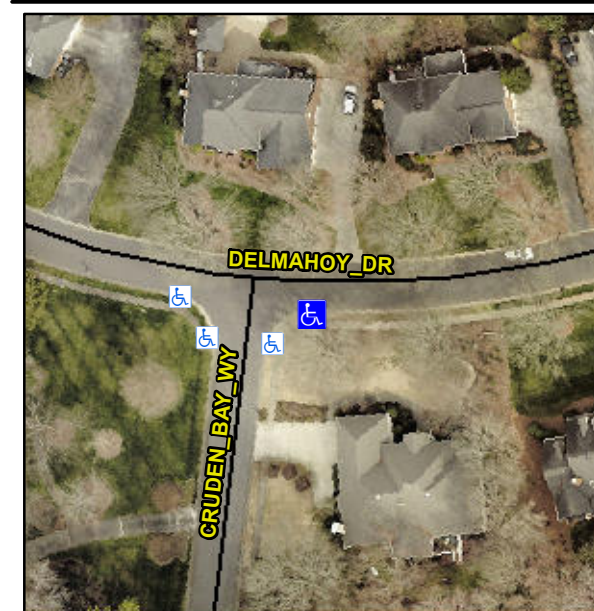
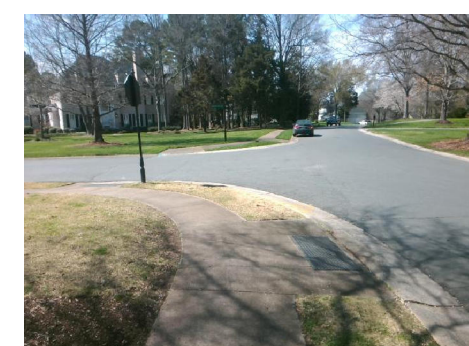
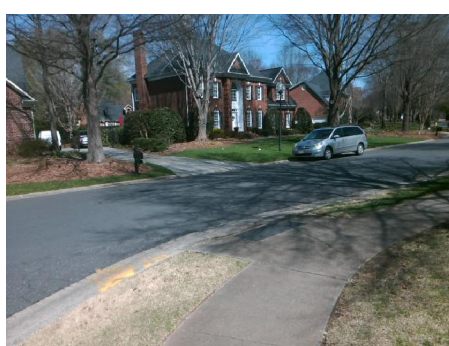
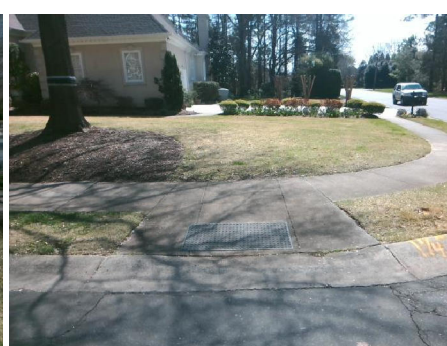
Not Found, R304.5.1, R304.2.2

Compliance	Description	Data	Compliance	Description	Data
N/A	Ramp Length (in)	92.0	No	Ramp Slope (%)	9.2
No	Ramp Width (in)	47.0	Yes	Ramp XSlope (%)	0.8
N/A	Flare Type LT	N/A	N/A	Flare Type RT	N/A
N/A	Flare Slope LT (%)	N/A	N/A	Flare Slope RT (%)	N/A
N/A	Flare Traversable LT?	N/A	N/A	Flare Traversable RT?	N/A
N/A	Landing Length (in)	N/A	N/A	DWS Provided?	N/A
N/A	Landing Width (in)	N/A	N/A	DWS Contrast?	N/A
N/A	Landing Slope (%)	N/A	N/A	DWS Length (in)	N/A
N/A	Landing X Slope (%)	N/A	N/A	DWS Full Width?	N/A
N/A	Landing Curb? (Y/N)	N/A	N/A	DWS Offset (in)	N/A
N/A	Shared Landing?	N/A			
N/A	Gutter Ponding?	N/A	N/A	Gutter Slope (%)	N/A
N/A	Gutter Lip Ht (in)	N/A	N/A	Gutter X Slope (%)	N/A
N/A	Painted X Walk1?	No	N/A	Painted X Walk2?	N/A
	X Walk 1 Direction	To N		X Walk 2 Direction	N/A
N/A	X Walk 1 Width (in)	N/A	N/A	X Walk 2 Width (in)	N/A
	X Walk 1 Slope (%)	0.3		X Walk 2 Slope (%)	N/A
	X Walk 1 X Slope (%)	1.7		X Walk 2 X Slope (%)	N/A

N/A	Ramp inside XWalk1?	N/A	N/A	Ramp inside XWalk2?	N/A
	Road Slope (%)	N/A	N/A	Clear Space?	N/A
	Road X Slope (%)	N/A	N/A	Clear Space to XWalk (in)	N/A
N/A	Any Obstructions?	N/A	N/A	Storm Grate/Utility Hazard?	N/A
	Obstruction Type			Storm Grate/Utility Type	
		N/A			N/A
			Yes	Surface Condition? (G/P)	Good

Remove & Replace Entire Ramp.
