# Access Compliance Report Public Rights-of-Way (Curb Ramps)

Intersection ID: 53960	Main Street: DENBUR_DR	Cross Street: MAGNOLIA_LILY_AV	Location: SE
ADA ID: EF9ED284A31E	Ramp Type: Combination2	Initial Pass/Fail: Fail	Overall Compliance: No Severity Score: 10

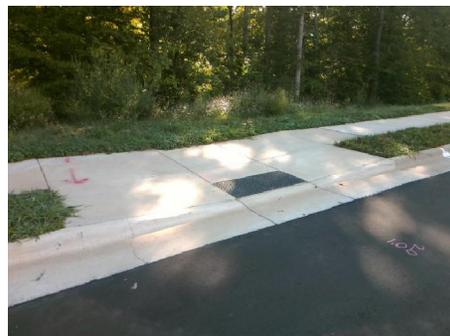
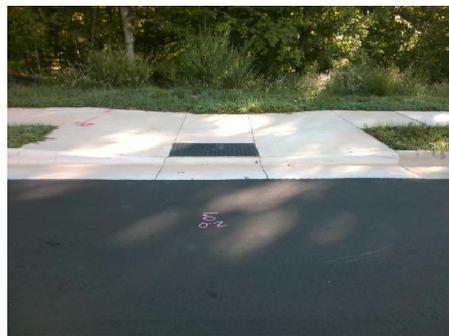
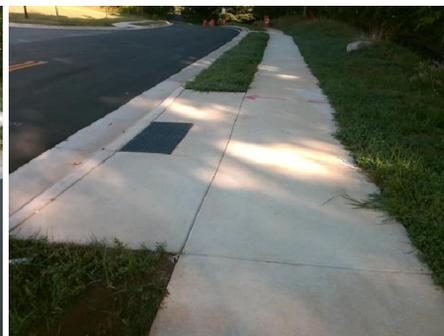
**RT RP < 5%**

**Not Found, R304.5.1, R304.5.3**

**Remove & Replace Entire Ramp.**
