## Access Compliance Report Public Rights-of-Way (Curb Ramps)

Intersection ID: 19223 Main Street: PARK\_RD Cross Street: VILLA\_HERMOSA\_DR Location: SW

ADA ID: EFAEDCBCB651 Ramp Type: BlendTrans2 Initial Pass/Fail: Fail Overall Compliance: No Severity Score: 12.5

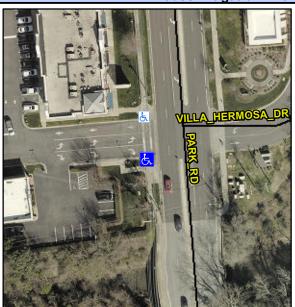
PROW/ADA:
Not Found, R304.5.3

Field Measurements/Component Compliance					
Compliance Description		Data	Compliance Description		Data
N/A	Ramp Length (in)	154.0	Yes	BlendTrans Slope (%)	3.9
Yes	Ramp Width (in)	48.0	No	BlendTrans XSlope (%)	5.4
N/A	Flare Type LT	N/A	N/A	Flare Type RT	N/A
N/A	Flare Slope LT (%)	N/A	N/A	Flare Slope RT (%)	N/A
N/A	Flare Traversable LT?	N/A	N/A	Flare Traversable RT?	N/A
N/A	Landing Length (in)	N/A	N/A	DWS Provided?	N/A
N/A	Landing Width (in)	N/A	N/A	DWS Contrast?	N/A
N/A	Landing Slope (%)	N/A	N/A	DWS Length (in)	N/A
N/A	Landing X Slope (%)	N/A	N/A	DWS Full Width?	N/A
N/A	Landing Curb? (Y/N)	N/A	N/A	DWS Offset (in)	N/A
N/A	Shared Landing?	N/A			
N/A	Gutter Ponding?	N/A	N/A	Gutter Slope (%)	N/A
N/A	Gutter Lip Ht (in)	N/A	N/A	Gutter X Slope (%)	N/A
N/A	Painted X Walk1?	No	N/A	Painted X Walk2?	No
	X Walk 1 Direction	To E		X Walk 2 Direction	To N
	X Walk 1 Width (in)	N/A		X Walk 2 Width (in)	N/A
	X Walk 1 Slope (%)	6.6		X Walk 2 Slope (%)	3.4

X Walk 1 X Slope (%)	4.8		X Walk 2 X Slope (%)	2.5
N/A	Ramp inside XWalk1?	N/A	N/A	Ramp inside XWalk2?	N/A
	Road Slope (%)	4.3		Clear Space?	N/A
	Road X Slope (%)	0.8	N/A	Clear Space to XWalk (in)	N/A
N/A	Any Obstructions?	N/A	N/A	Storm Grate/Utility Hazard?	N/A
	Obstruction Type		l	Storm Grate/Utility Type	
		N/A			N/A
			Yes	Surface Condition? (G/P)	Good
The same of the sa			No	Curb Slope (%)	6.0

Remove & Replace Curb Ramp With
Two New Directional Ramps or
Equivalent.
