## Access Compliance Report Public Rights-of-Way (Curb Ramps)

Intersection ID: 10038412 Main Street: SOUTH\_POINT\_BV Cross Street: N/A Location: W

ADA ID: EFB0606A18F8 Ramp Type: Perp Initial Pass/Fail: Fail Overall Compliance: No Severity Score: 13.75

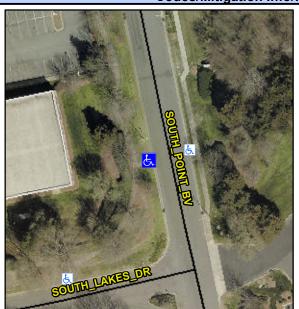
Comp	liance Description	Data	Comp	liance	Description	Data
N/A	Ramp Length (in)	47.0	No	Ramp	Slope (%)	9.6
Yes	Ramp Width (in)	48.0	Yes	Ramp	XSlope (%)	2.1
N/A	Flare Type LT	N/A	N/A	Flare	Type RT	N/A
N/A	Flare Slope LT (%)	N/A	N/A	Flare	Slope RT (%)	N/A
N/A	Flare Traversable LT?	N/A	N/A	Flare	Traversable RT?	N/A
N/A	Landing Length (in)	N/A	N/A	DWS	Provided?	N/A
N/A	Landing Width (in)	N/A	N/A	DWS	Contrast?	N/A
N/A	Landing Slope (%)	N/A	N/A	DWS	Length (in)	N/A
N/A	Landing X Slope (%)	N/A	N/A	DWS	Full Width?	N/A
N/A	Landing Curb? (Y/N)	N/A	N/A	DWS	Offset (in)	N/A
N/A	Shared Landing?	N/A				
N/A	Gutter Ponding?	N/A	N/A	Gutte	r Slope (%)	N/A
N/A	Gutter Lip Ht (in)	N/A	N/A	Gutte	r X Slope (%)	N/A
N/A	Painted X Walk1?	No	N/A	Paint	ed X Walk2?	N/A
	X Walk 1 Direction	To E		X Wa	lk 2 Direction	N/A
N/A	X Walk 1 Width (in)	N/A	N/A	X Wa	lk 2 Width (in)	N/A
	X Walk 1 Slope (%)	2.5		X Wa	lk 2 Slope (%)	N/A
	X Walk 1 X Slope (%)	3.1		X Wa	lk 2 X Slope (%)	N/A

rossible solution	
Possible Solutions:	Co
Remove & Replace Entire Ramp.	N/A
	Yes
	N/A
	N/A
	N/A
	N/A
Surveyor Notes:	N/A
N/A	N/A
	N/A
	N/A
	N/A
PROW/ADA:	N/A
Not Found, R304.2.2	N/A
	N/A
	N/A
	N/A
